ST THOMAS' CHURCH TOWER, MUSBURY

INVESTIGATION OF MASONRY AND TIMBER CONDITION

JOB NO. 213-66

11-13 APRIL 2023

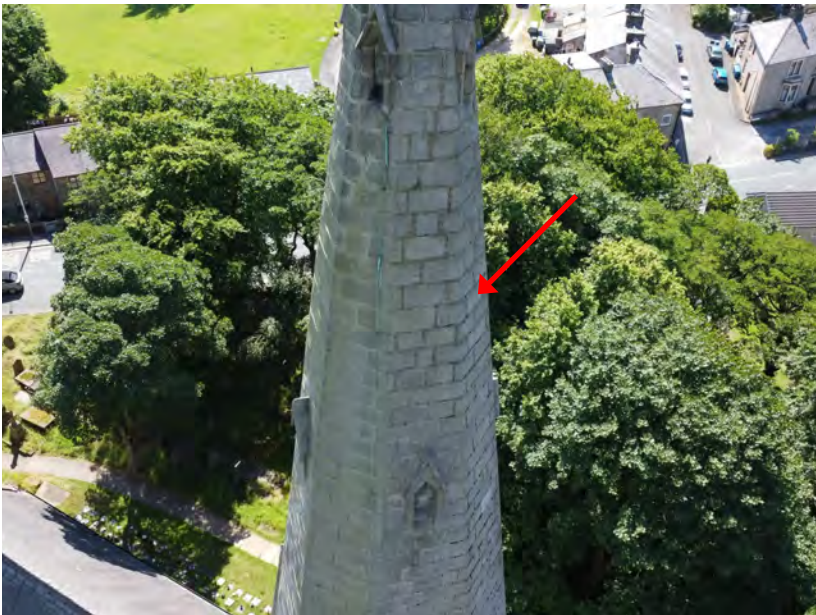
Fig 10:

North-west; showing example of area of spire with erosion to the mortar joints

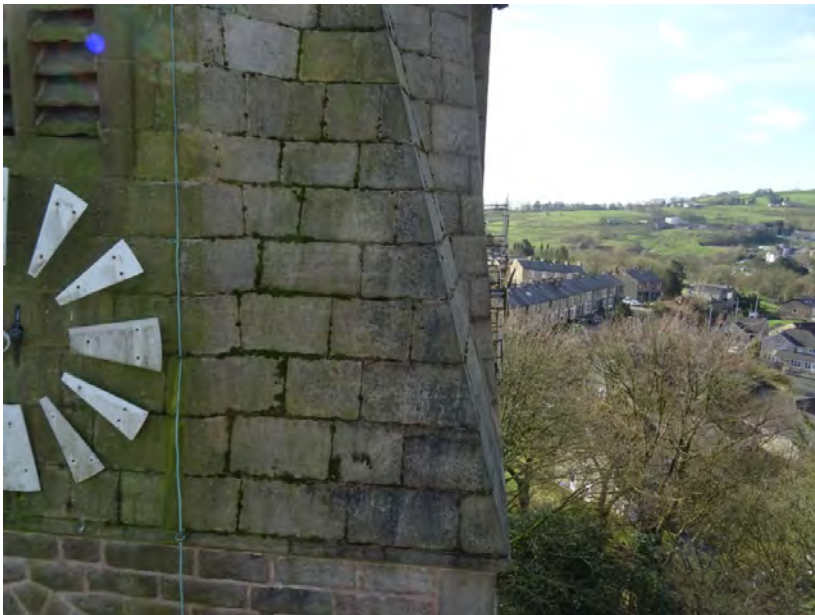
Fig 12:

North to north-east spire; showing moss growth in heavily degraded mortar joints, some of which are void

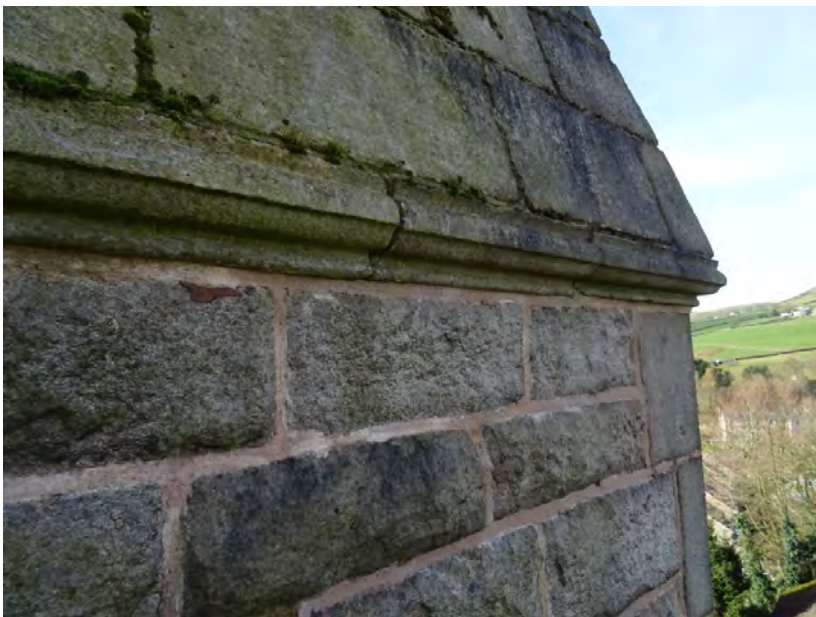
Fig 14:

West elevation; showing uppermost projecting string course of the tower and the interface of modern NHL repointing work and older pointing of the spire

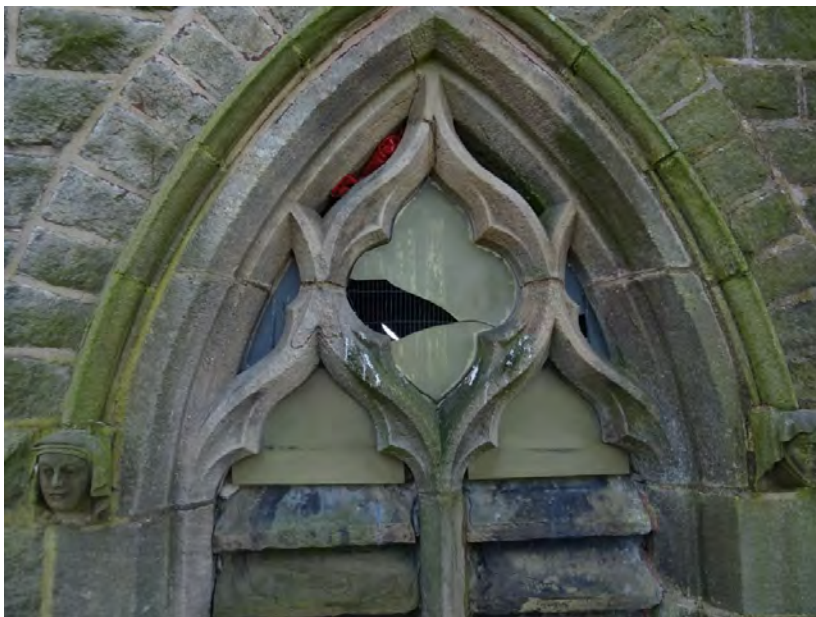
Fig 16:

North elevation; showing general view of window arch and tracery. Broken glass noted

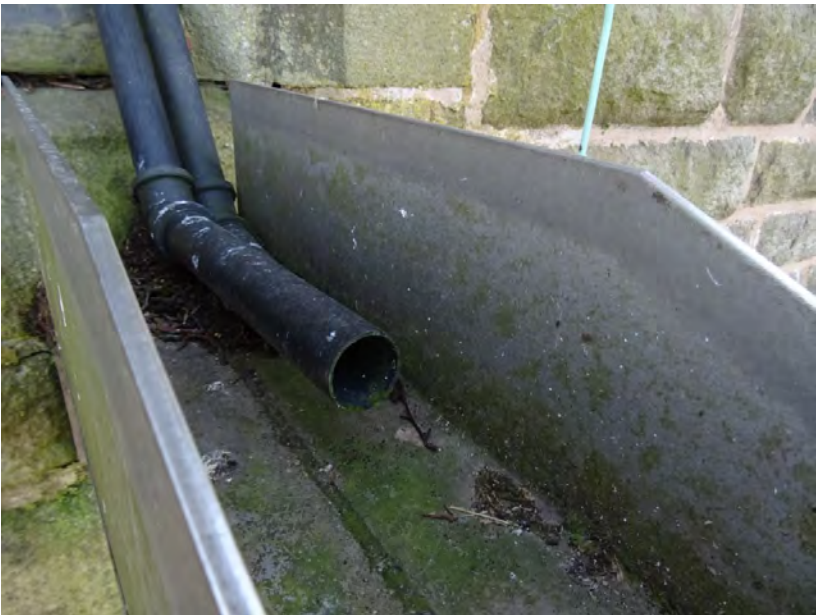
Fig 18:

North elevation, fourth floor level;
showing plastic drainage pipes
discharging (now blocked) into
stainless steel chute

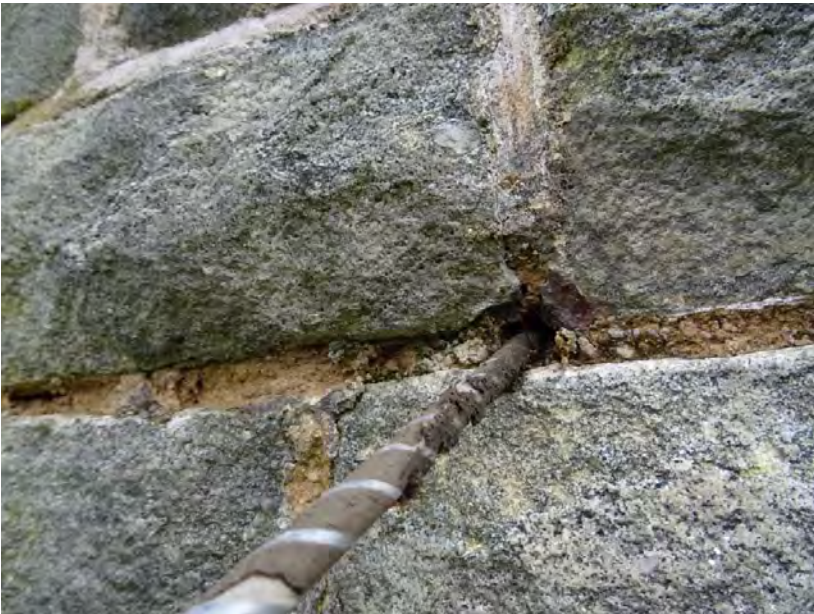
Fig 32:

West elevation; showing where voiding and wet mortar where found at high level on the tower

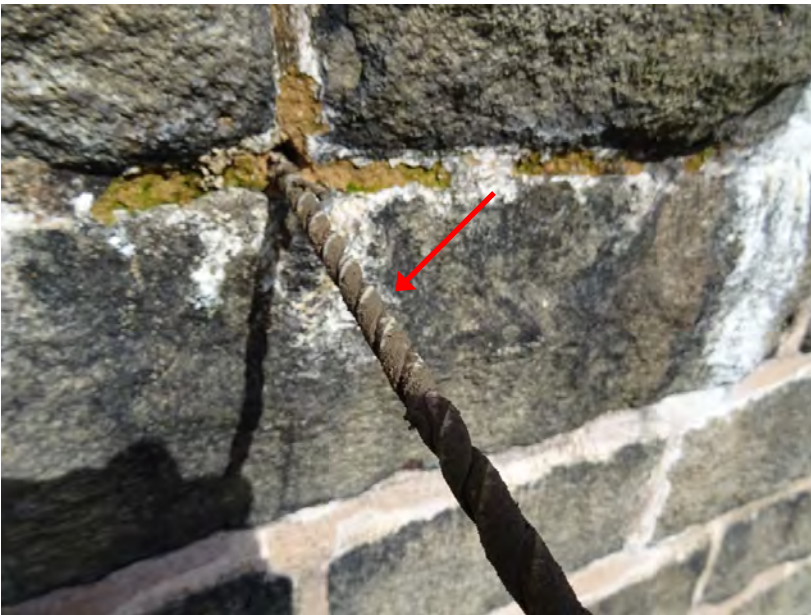
Fig 42:

South elevation, upper level of the tower; showing degraded re-pointing and saturated mortar/soil compound clinging to drill bit

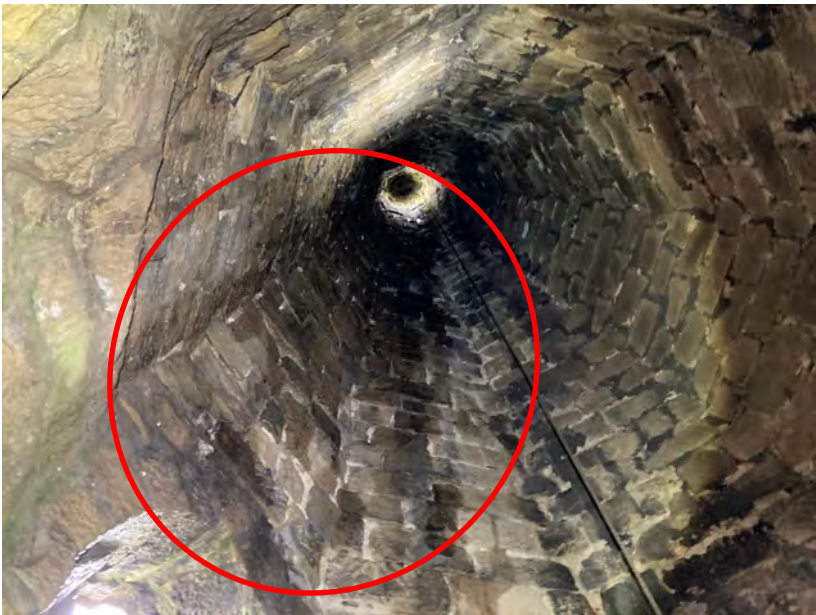
Fig 44:

4th floor/spire; showing water freely penetrating the south-west aspect of the spire masonry during a period of driving rain

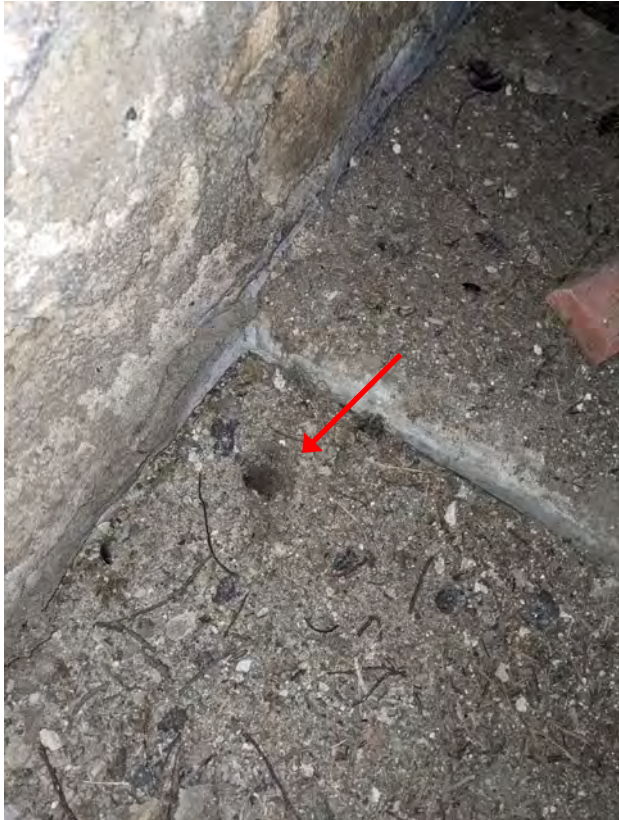
Fig 49:

4th floor (Clock Tower); showing the outlet from the gutter. The outlet was only approximately 60mm in diameter

Both outlets and drainage channels were blocked by debris and bird detritus

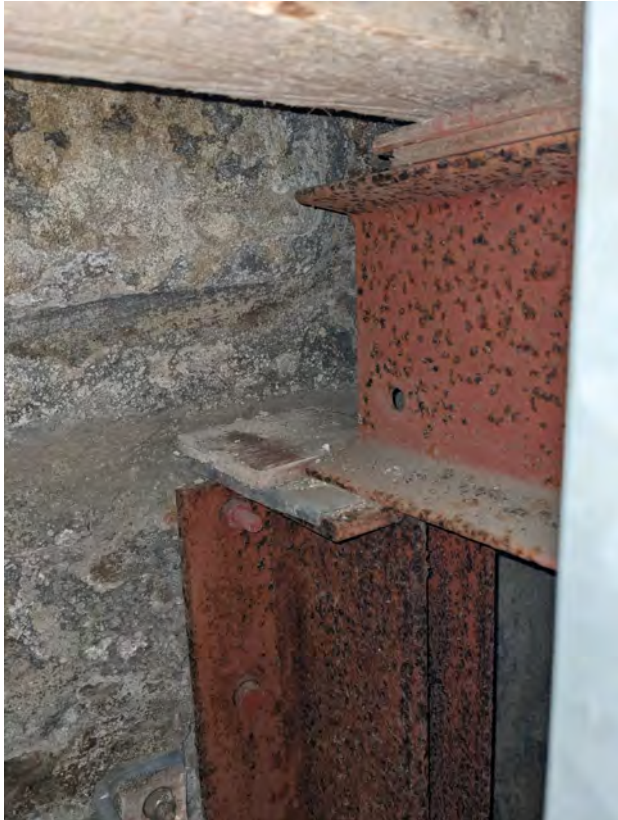
Fig 55:

3rd floor (Belfry); showing 4th floor structure steel support

Steel has been added in response to decay in the bearing end of joists. Steels beams were supported on a steel post bolted to the wall

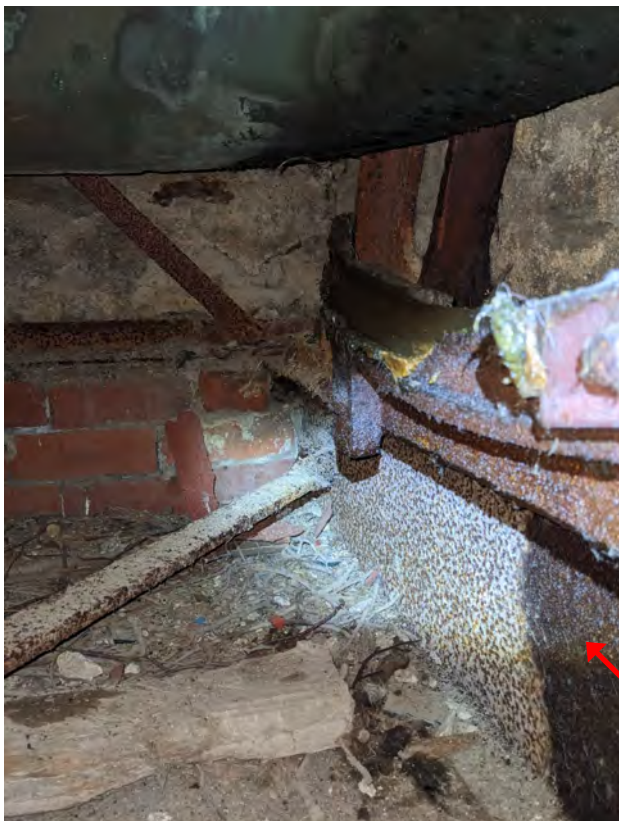
Fig 60:

3rd floor (Belfry); showing example of superficial corrosion to the bell frame

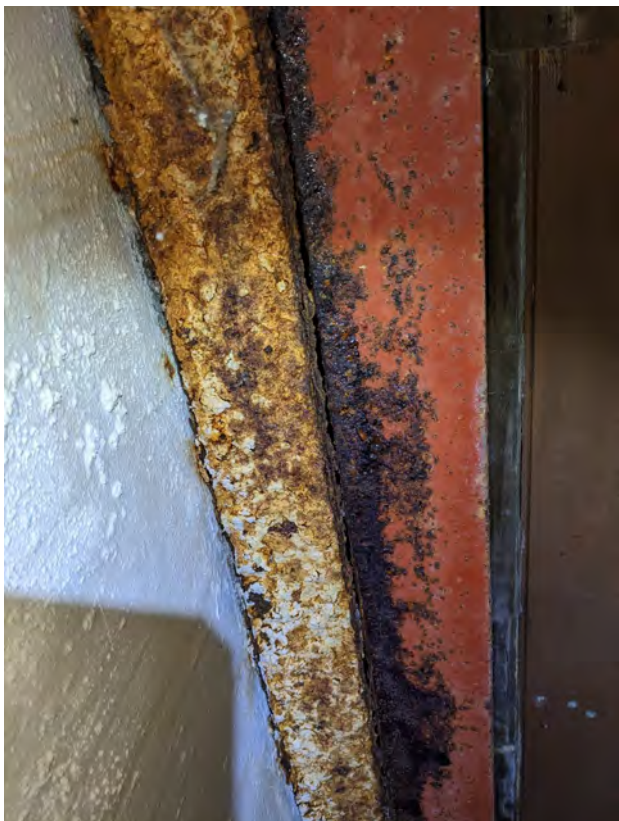
Fig 66:

2nd floor (Ringing Chamber); showing steel beams and a close-up of the corrosion to the steels

- 4.5.1 Structural steels: The corrosion of structural steels to all floors, including those supporting the bells, should be assessed in detail and the results should inform a schedule of repairs or refurbishments

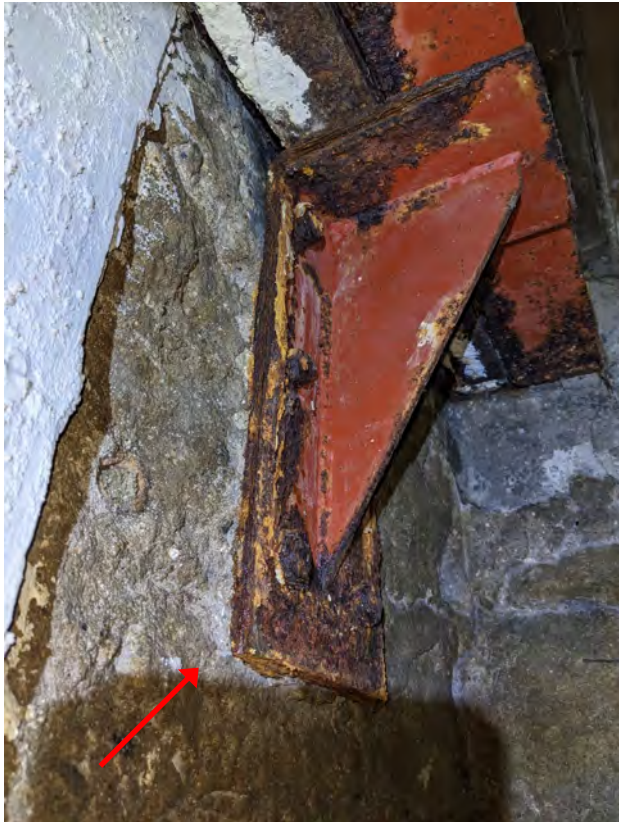
Fig 67:

2nd floor (Ringing Chamber); showing steel bracket supporting steel beams above

The steel brackets should be further investigated

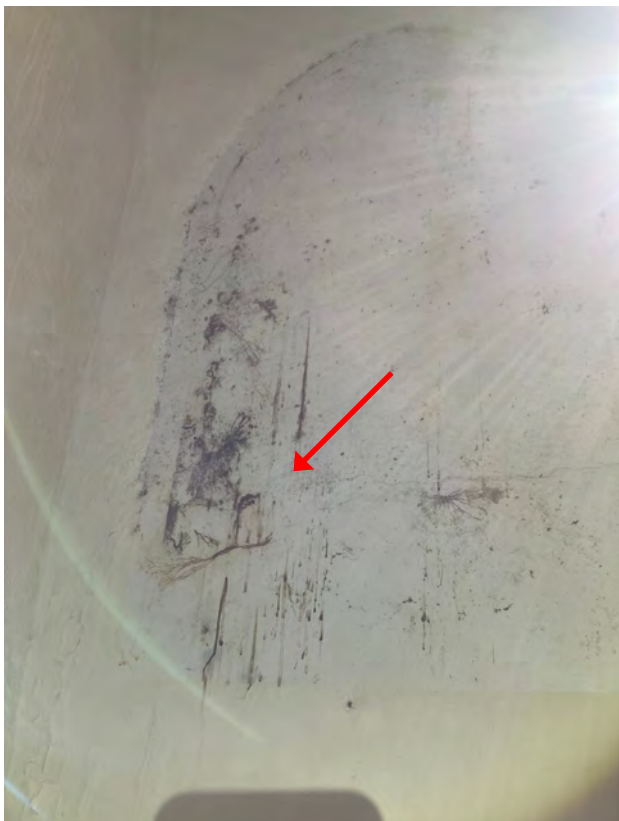
Fig 68:

2nd floor (Ringing Chamber); showing remnants of a wet rot fungus on wall where timber plaque was previously hung

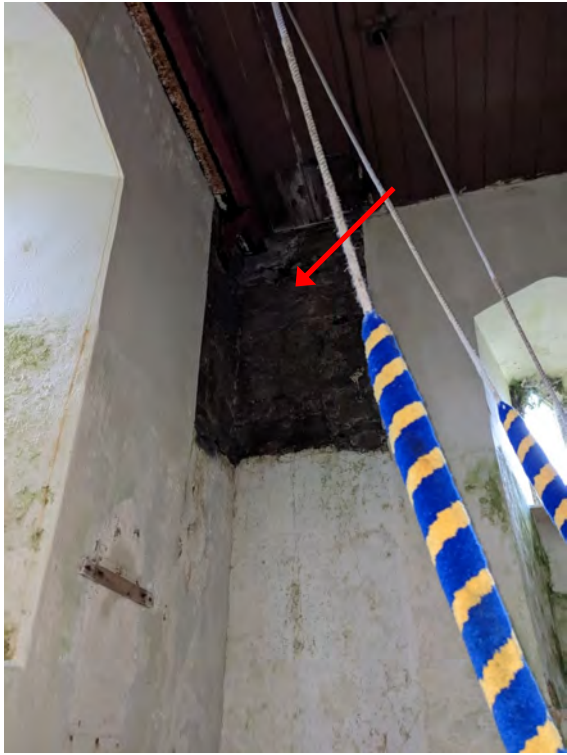
Fig 69:

2nd floor (Ringing Chamber); showing algal growth and area where plaster had failed

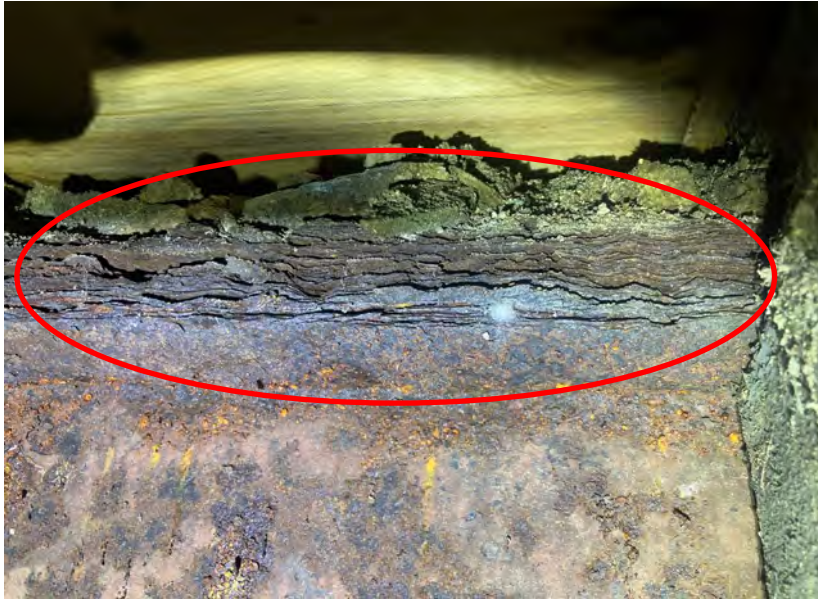
Fig 73:

1st floor (Organ Blower Room), second floor structure; showing corrosion and expansion of the upper flange of the older steel beam

- 4.3.2 Second floor joists: Allowances should also be made for repair of joists to the second floor that have been structurally compromised due to the expansion of the steel beam

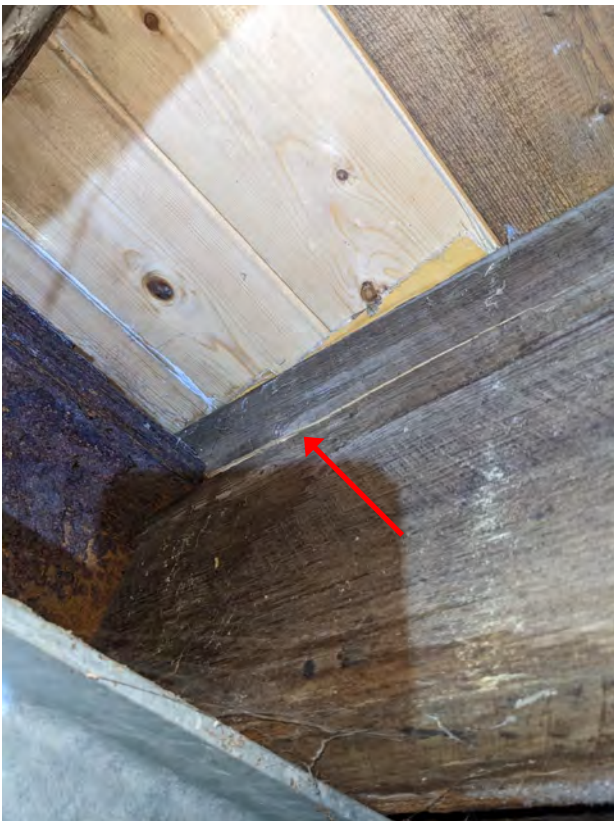
Fig 74:

1st floor (Organ Blower Room), second floor structure; showing an example of a horizontal fissure that has occurred in the top third of the joists

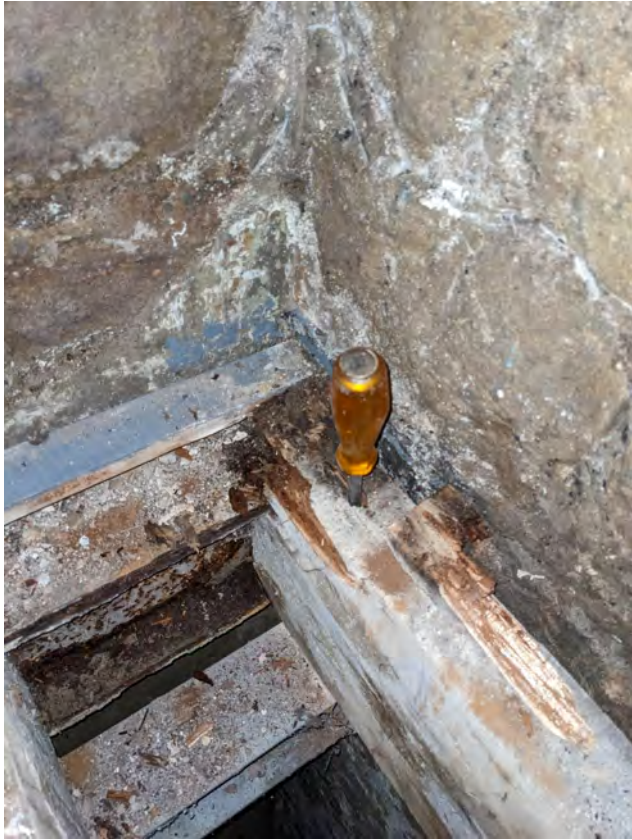
Fig 75:

2nd floor (Ringing chamber), north west corner; showing an example of a second floor joist decayed by wet rot

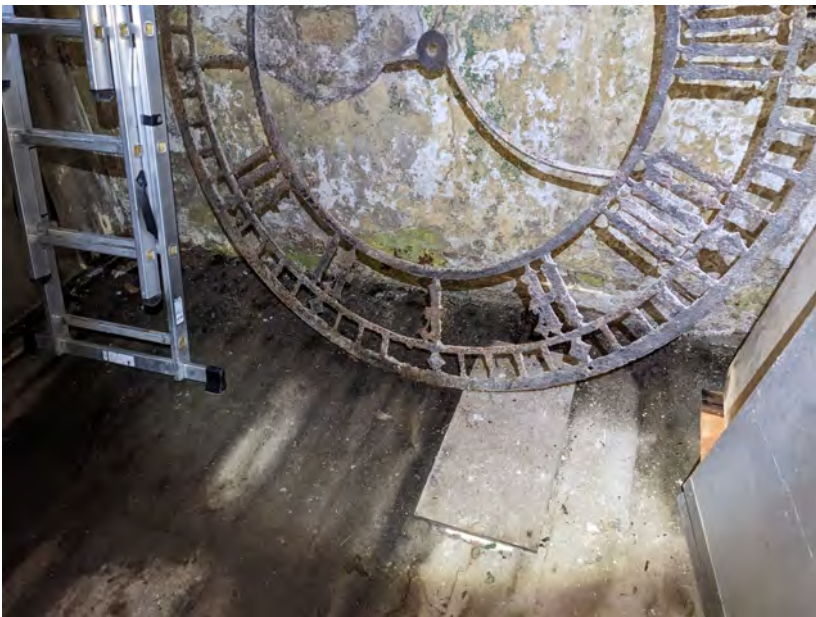
Fig 78:

1st floor (Organ Blower Room);
showing visibly wet timber floorboards
on the west elevation

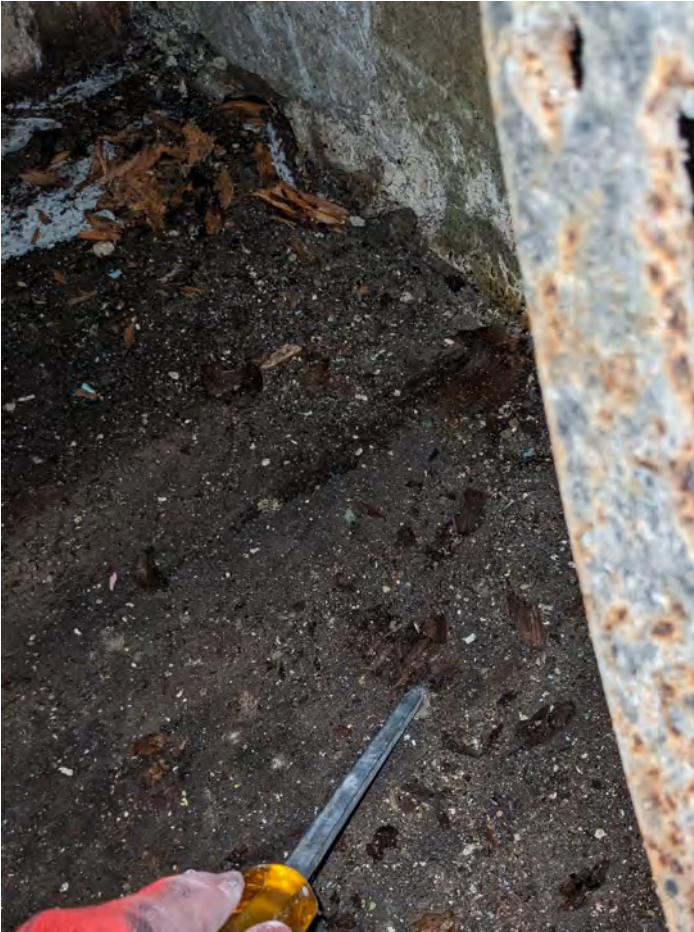
Fig 79:

1st floor (Organ Blower Room);
showing floorboards decayed by wet
rot on the west elevation

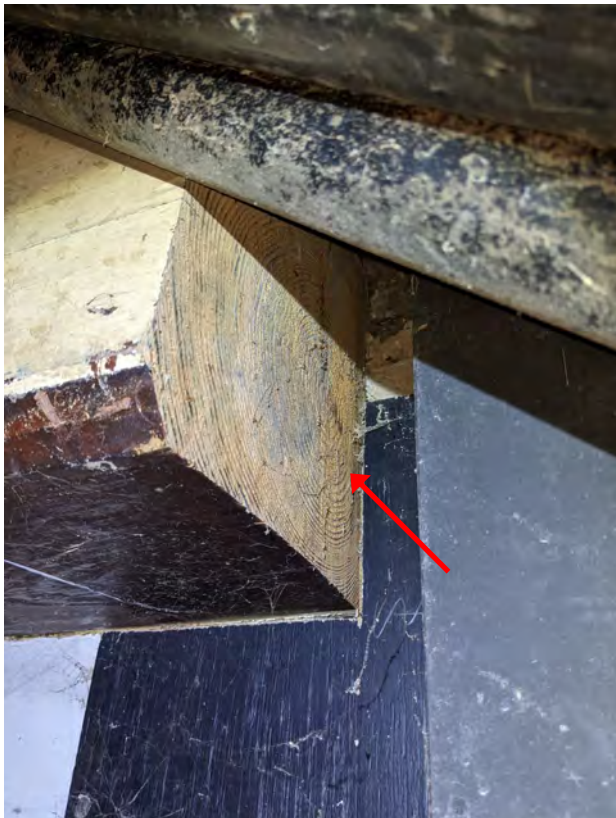
Fig 82:

Ground floor; showing the primary timber beam along the east wall which has been cut

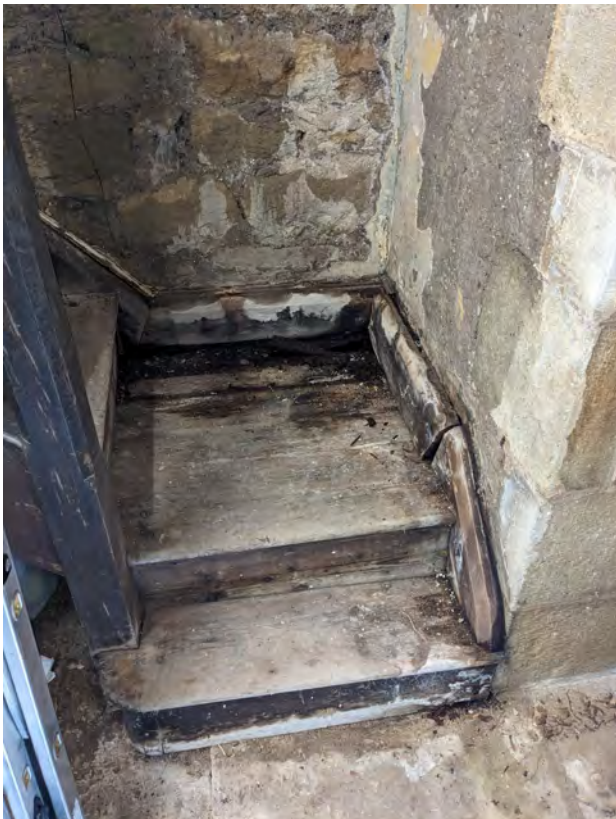
Fig 84:

Ground floor; showing decayed timber at the foot of the staircase

- 4.2.3 Allowance should be made for release of the ground floor staircase, for its repair and reinstatement, isolating its timbers from direct contact with damp masonry

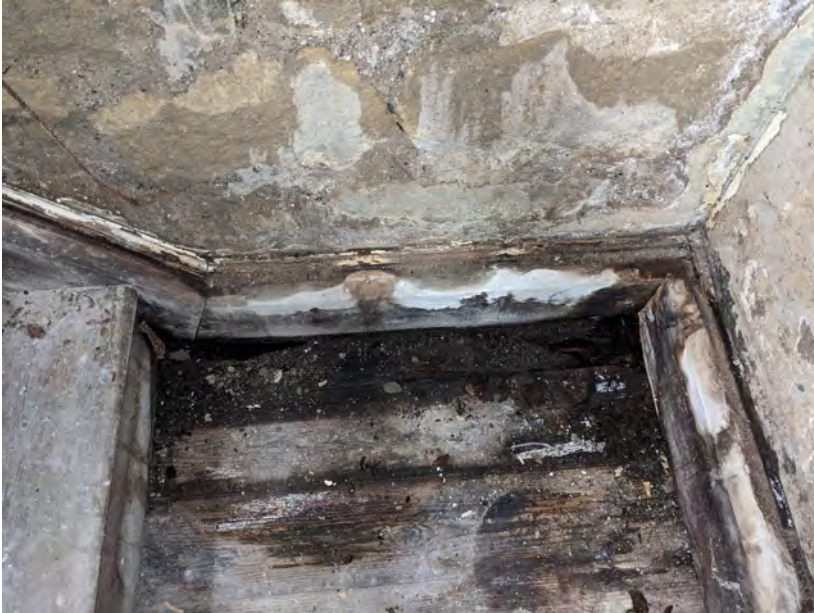
Fig 85:

Ground floor; showing wet rot decay of the landing timbers at the foot of the staircase

Staircase timbers in contact with west and south walls in this location are at continuing risk of decay
