ST THOMAS' CHURCH TOWER, MUSBURY

INVESTIGATION OF MASONRY AND TIMBER CONDITION

JOB NO. 213-66

11-13 APRIL 2023

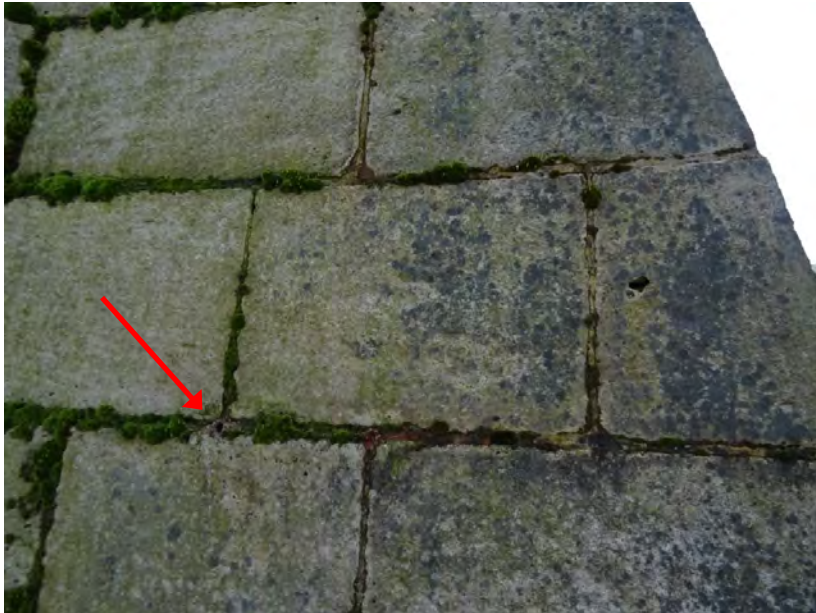
Fig 13:

North to north-east spire: showing moss growth in saturated mortar joints at the broach

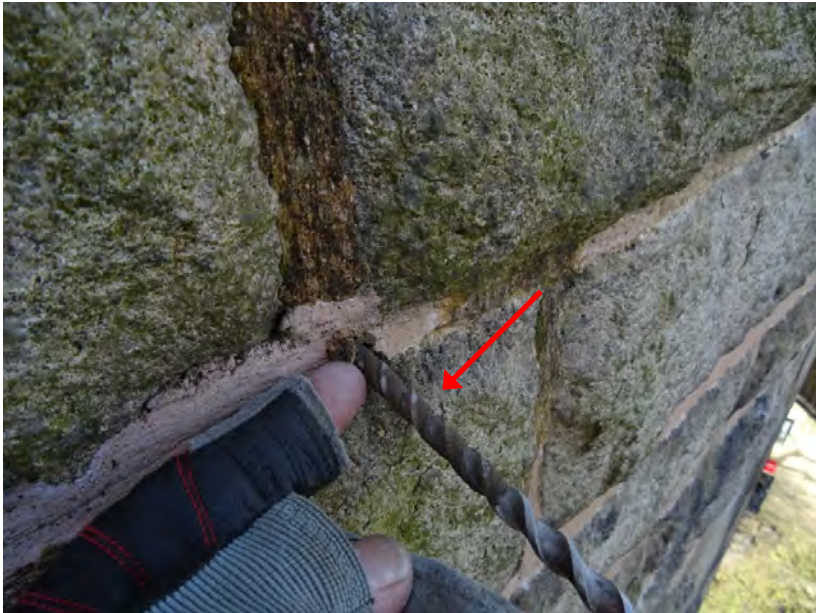
Fig 15:

North elevation, top of tower; showing an example of saturated mortar clinging to the drill bit. Beyond this 100mm of wet mortar, the joint was void

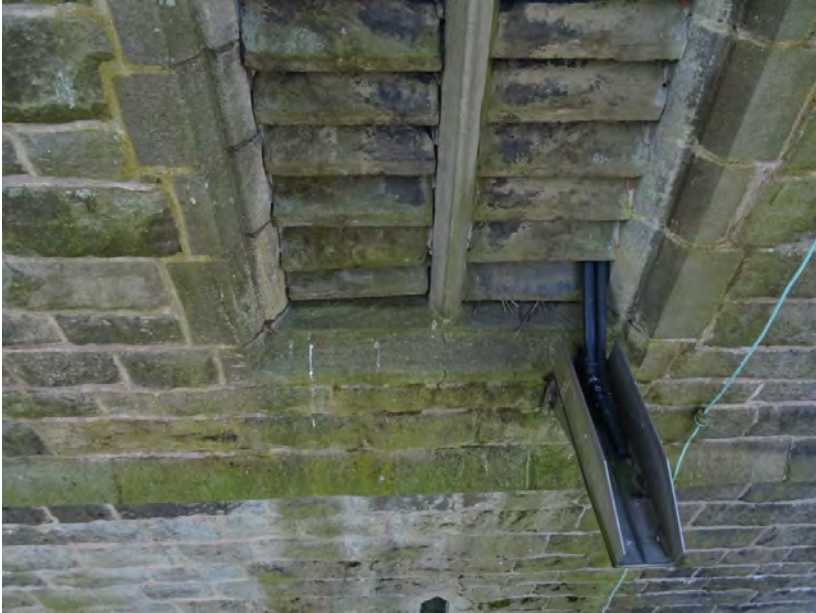
Fig 17:

A sheet lead covering to the uppermost floor requires further consideration. If it is to be retained, allowance should be made for alterations to its drainage arrangements because they are dysfunctional. Corrosion of steel beams and corbels supporting the floors requires further investigation

North elevation, fourth floor level;
showing drainage chute serving
internal lead covered deck

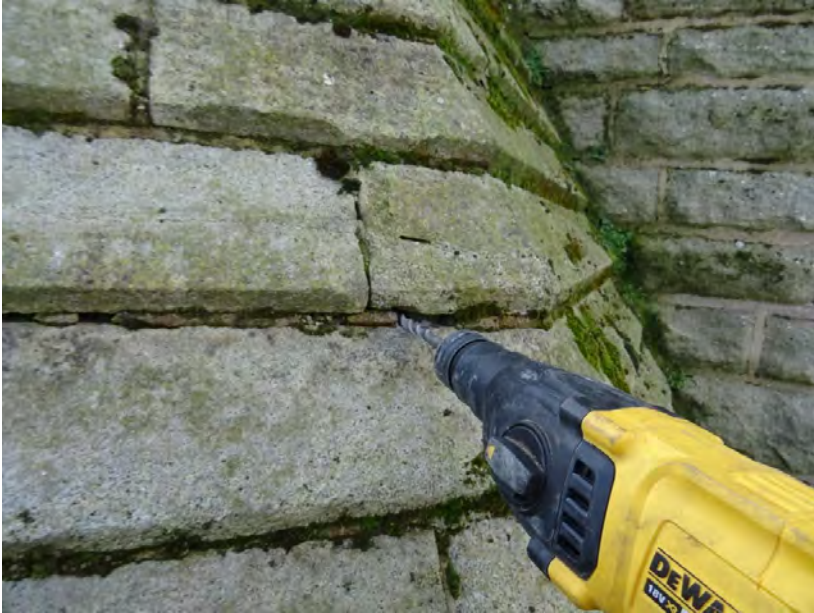
Fig 21:

North elevation; showing voiding of joints in the stair tower roof masonry

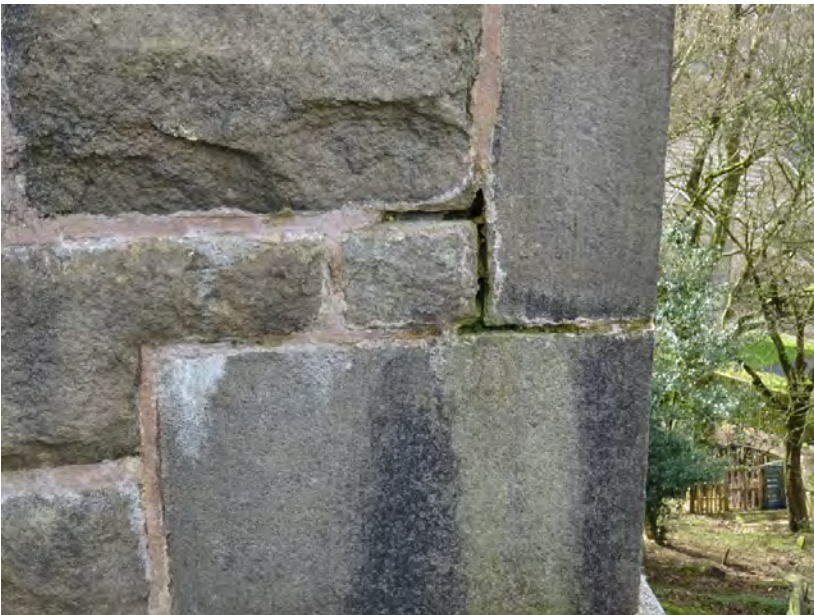
Fig 22:

North elevation, mid-level of tower; showing perished areas of repointing works which were carried out in 2017

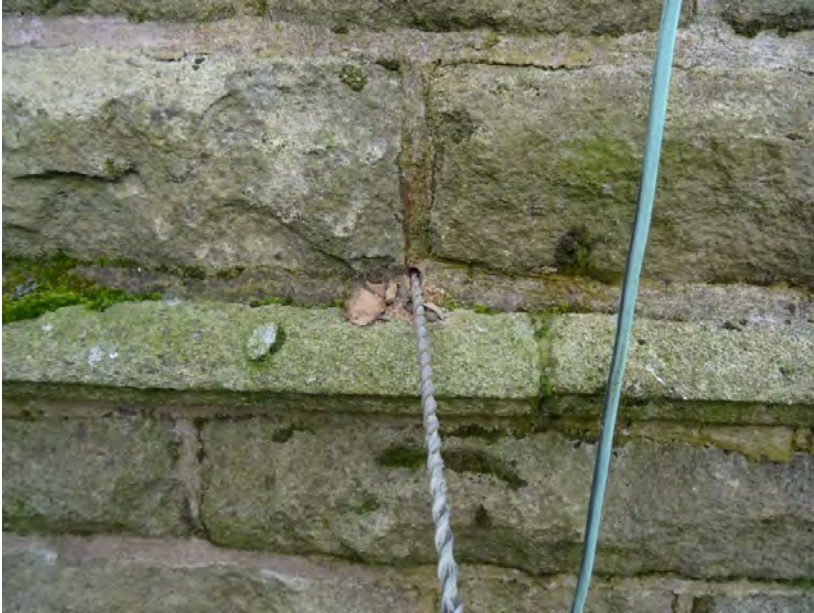
Fig 23:

North elevation; showing test location where joint voiding above the bottom string course was determined by drill

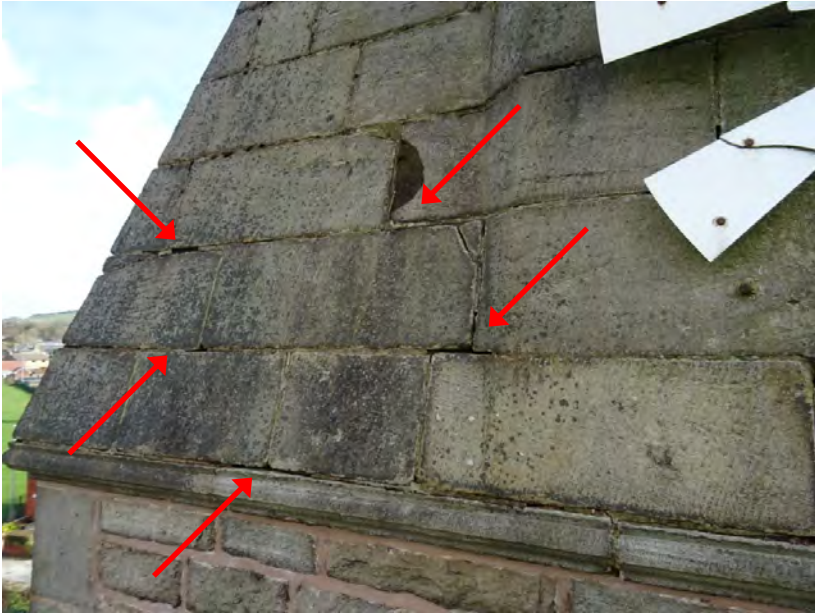
Fig 25:

West elevation; showing open and void mortar joints at lower level on the spire

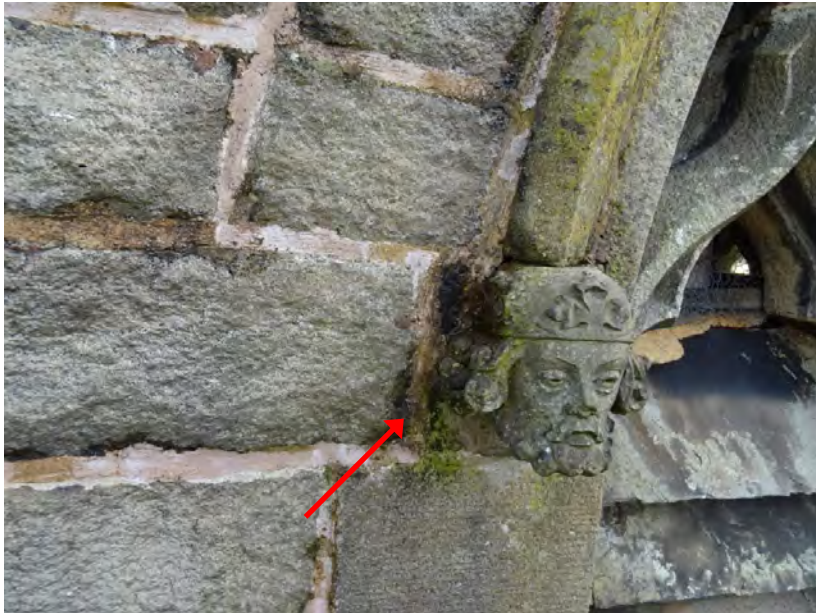
Fig 27:

West elevation; showing water exuding at the base of window hood detail

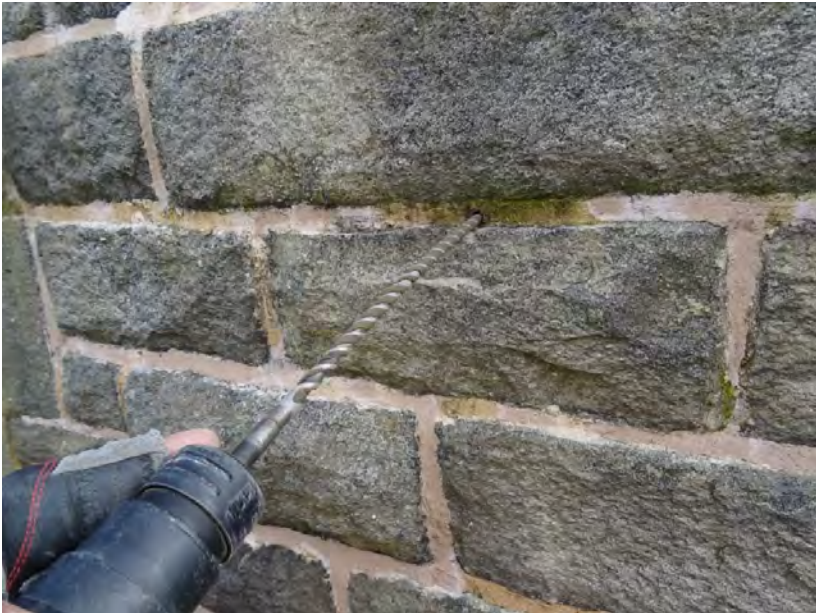
Fig 29:

West elevation; showing void detection at high level of the tower

Note; the saturated mortar clinging to the drill bit

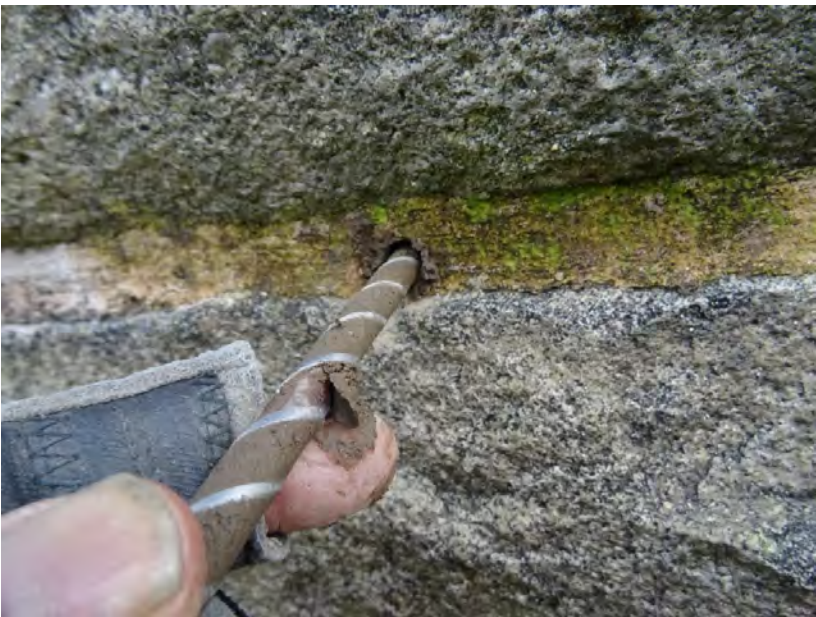
Fig 30:

West elevation; showing void detection at high level of the tower

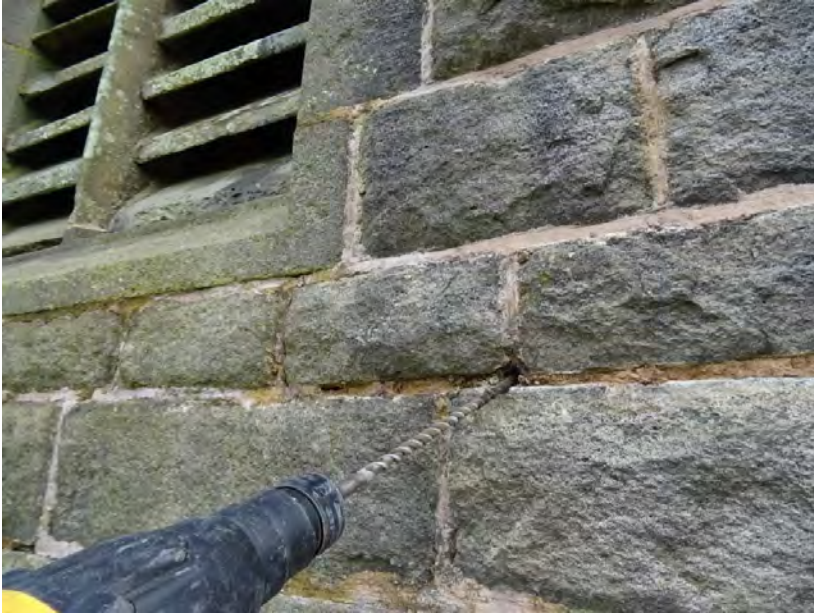
Fig 31:

West elevation; showing void detection at high level of the tower

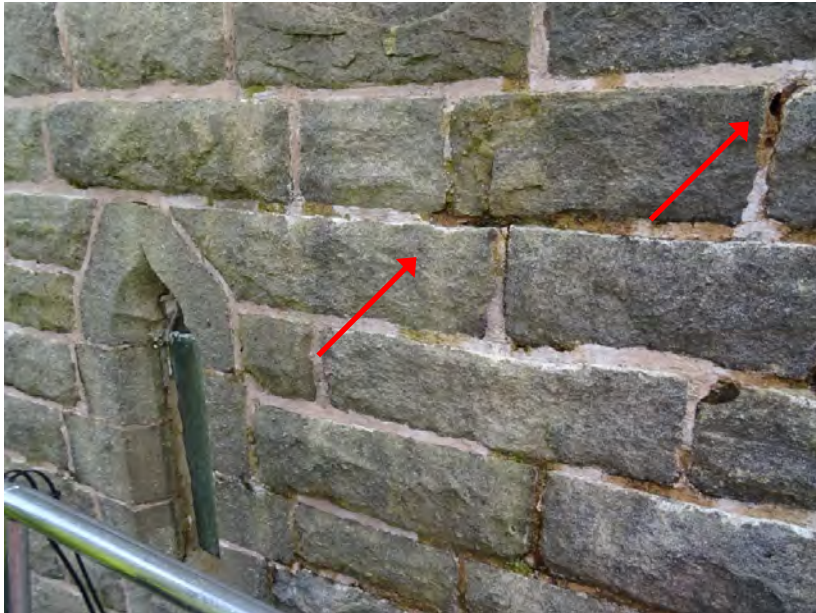
Fig 33:

West elevation,; showing mid level of tower

Note; the degraded and washed-out mortar repointing of works carried out in 2017

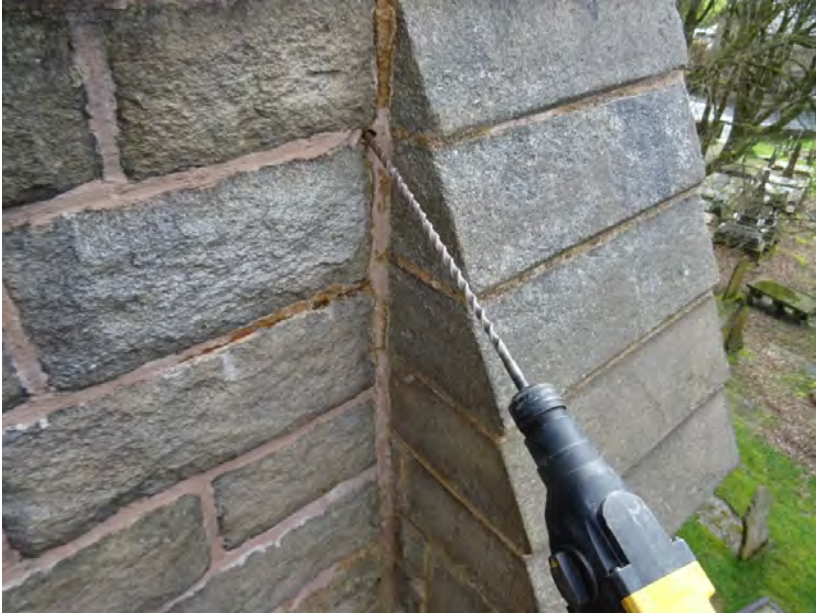
Fig 35:

West elevation; showing void detection at lower level of the tower

Note; the saturated mortar clinging to drill bit

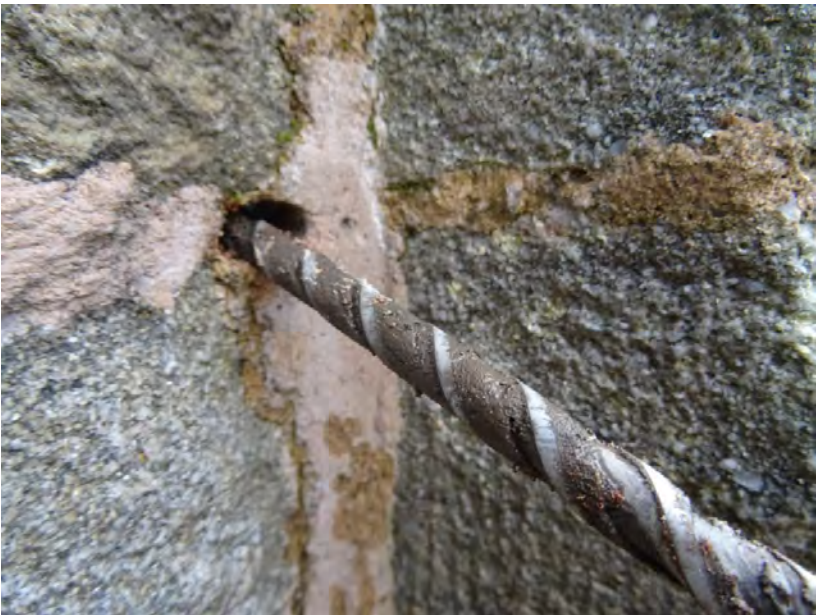
Fig 36:

West elevation; showing void detection at lower level of the tower

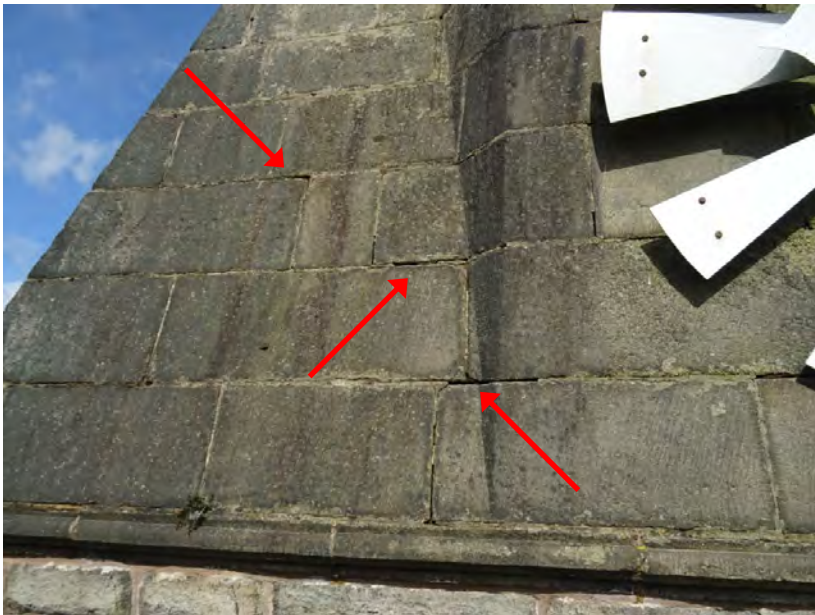
Fig 38:

South elevation; showing open and void mortar joints at the broach of the spire

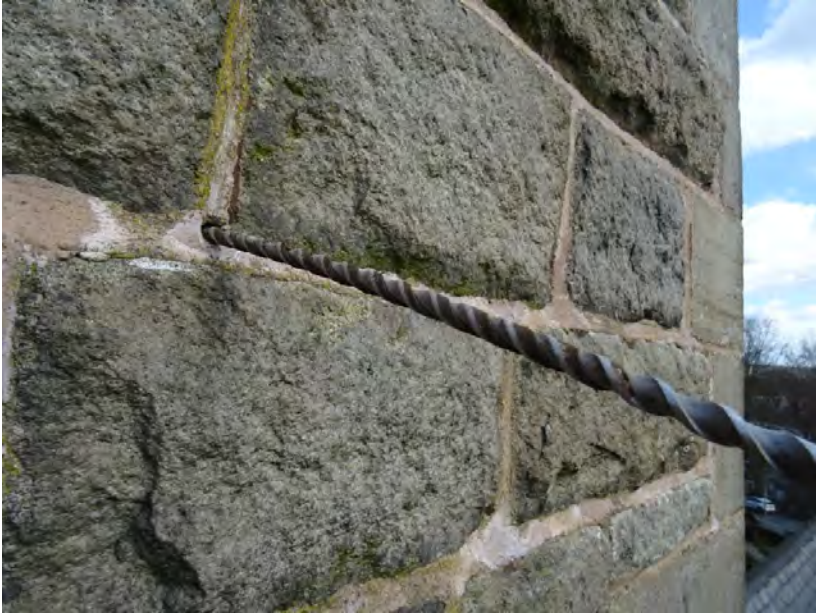
Fig 43:

South elevation; showing void detection at mid level of the tower

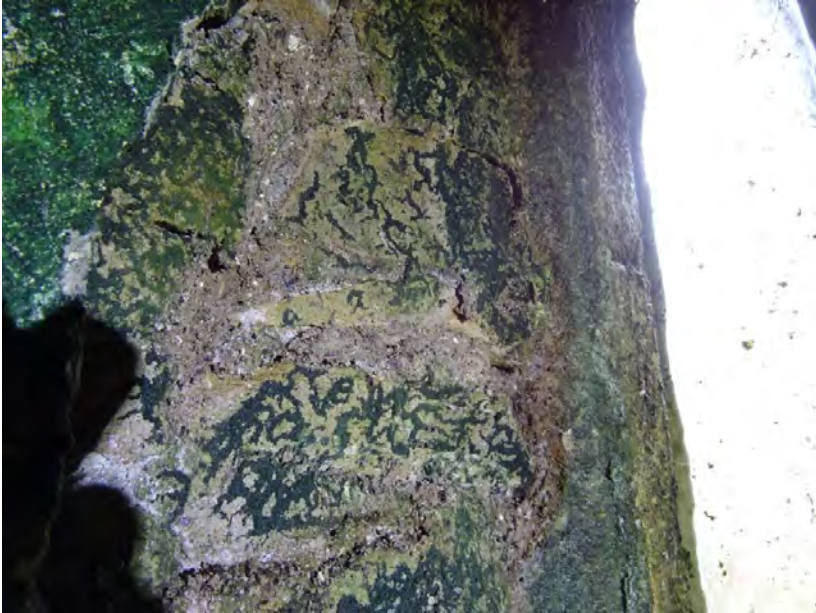
Fig 45:

4th floor (Clock Tower); showing algal growth on the internal wall of the spire

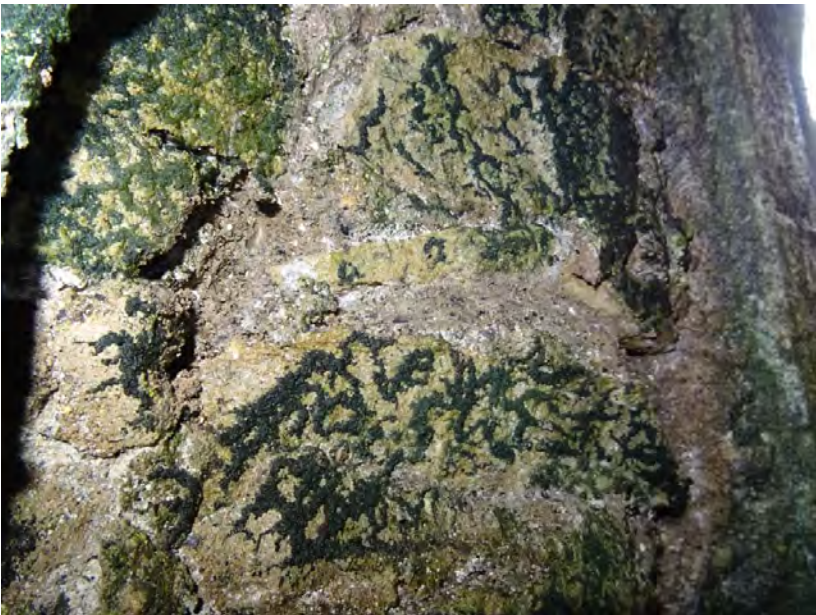
Fig 46:

4th floor (Clock Tower); showing algae on the internal wall of the spire

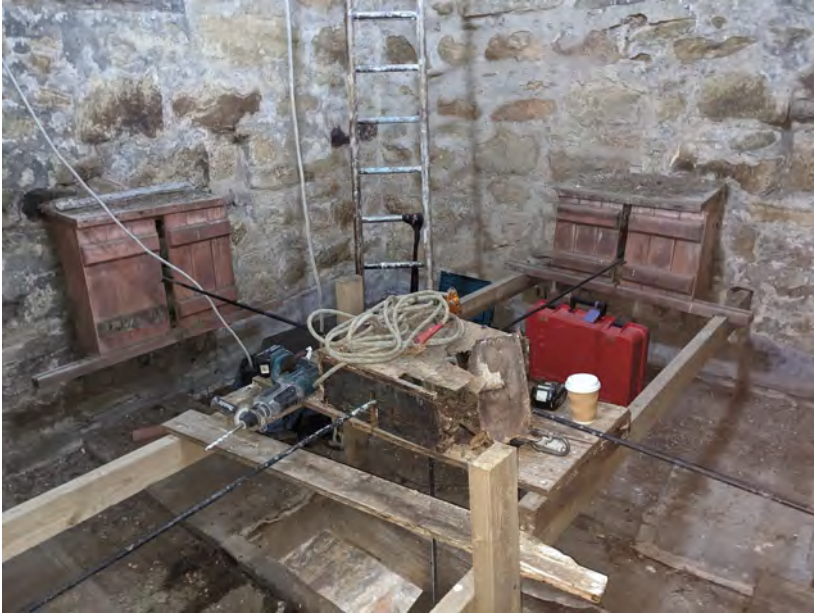
Fig 47:

4th floor (Clock Tower); showing lead covering to deck

Lead had been chased into the wall to form an upstand, with an overlapping flashing

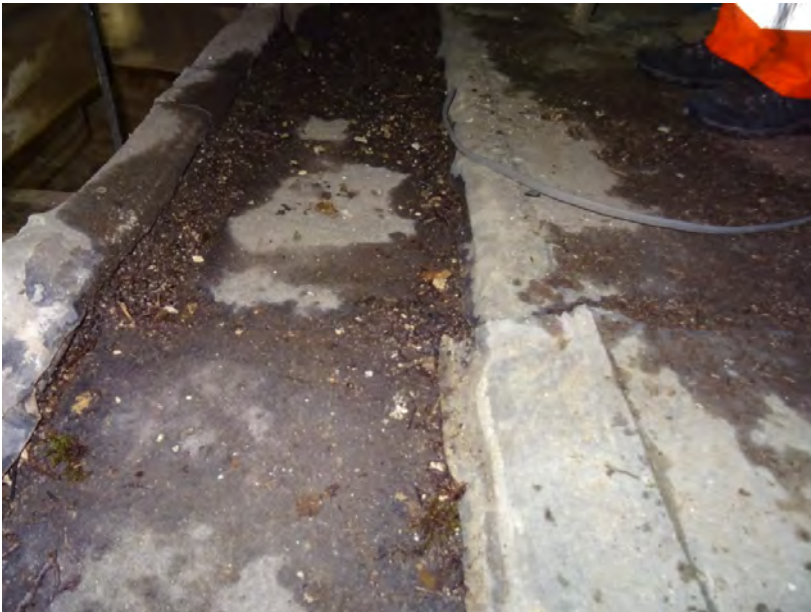
Fig 48:

4th floor (Clock Tower); showing gutter formed in lead deck

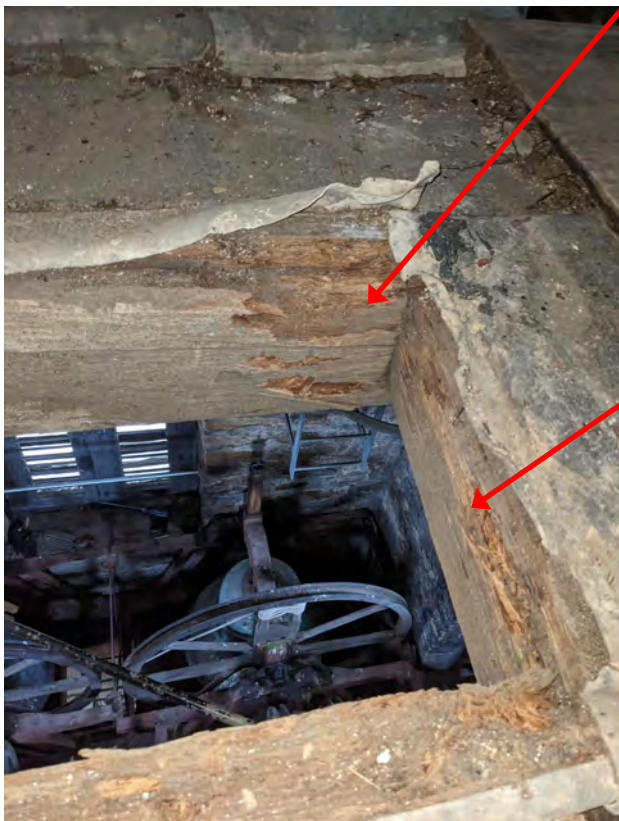
Fig 50:

Trimmer joist

The joists and trimmer joists around the opening were wet and structurally decayed by wet rot. Water penetration was occurring from the leaking spire above

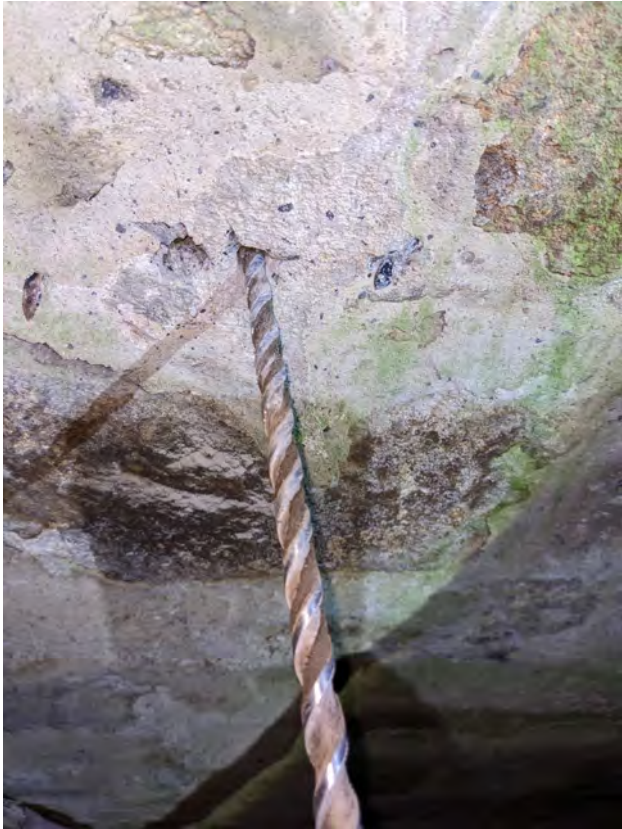
Fig 51:

4th floor (Clock Tower); showing mortar sampling for gravimetric testing

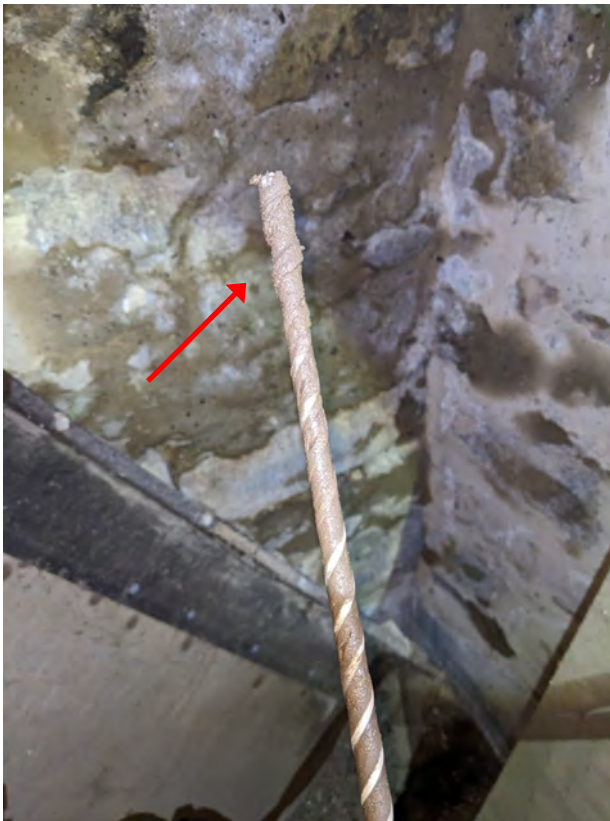
Fig 52:

4th floor (Clock Tower); showing mortar sampling for gravimetric testing

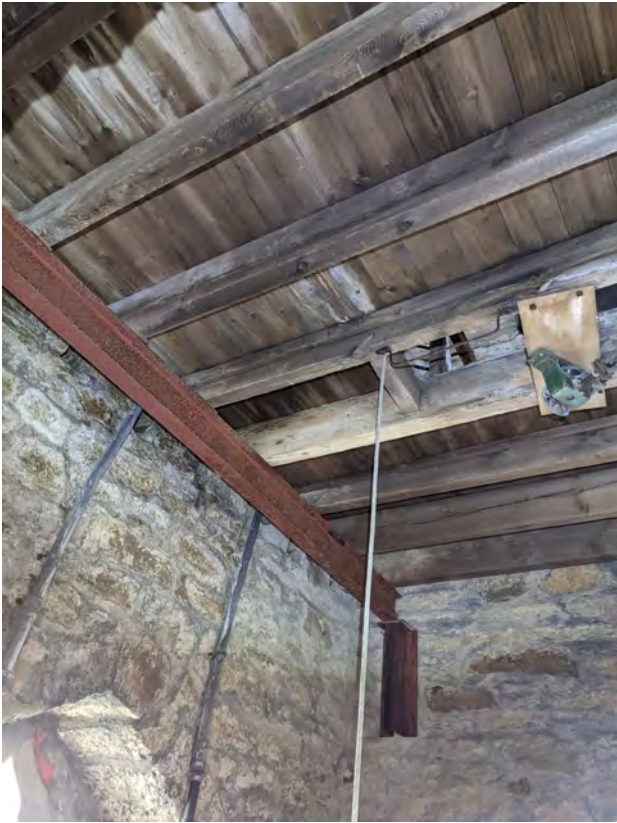
Fig 53:

3rd floor (Belfry): showing 4th floor structure

The floor was softwood joists and floorboards. Although joists had originally been supported in the wall; the ends had been trimmed and joists were now supported by steel beams

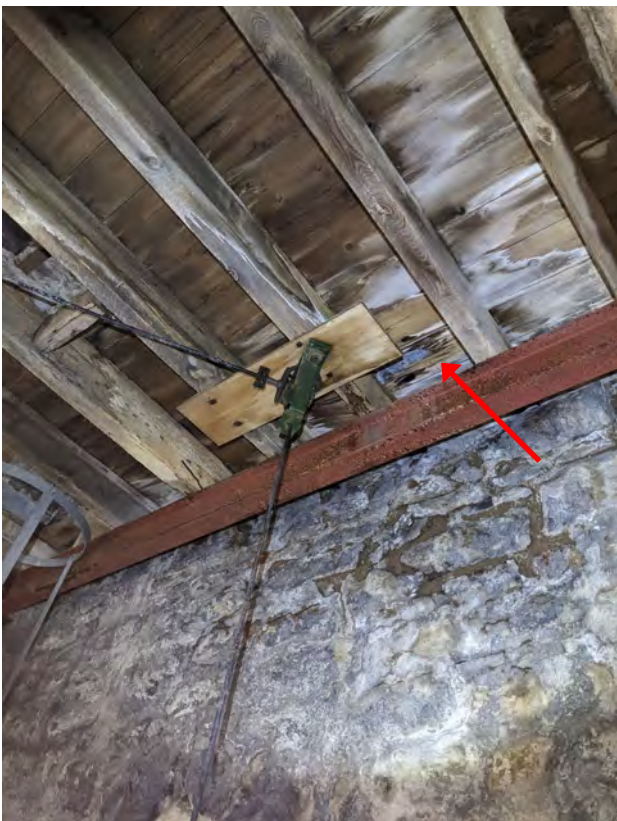
Fig 54:

3rd floor (Belfry): showing 4th floor structure

Note the area of decay and damp staining to the floorboards, which indicates that water penetration is occurring

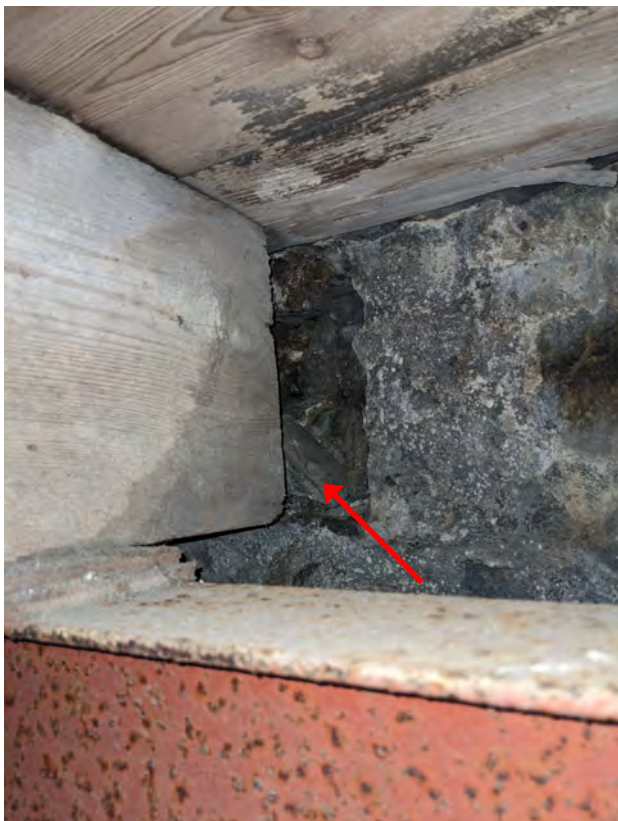
Fig 56:

3rd floor (Belfry); showing 4th floor; showing a former masonry pocket where joists had previously been embedded

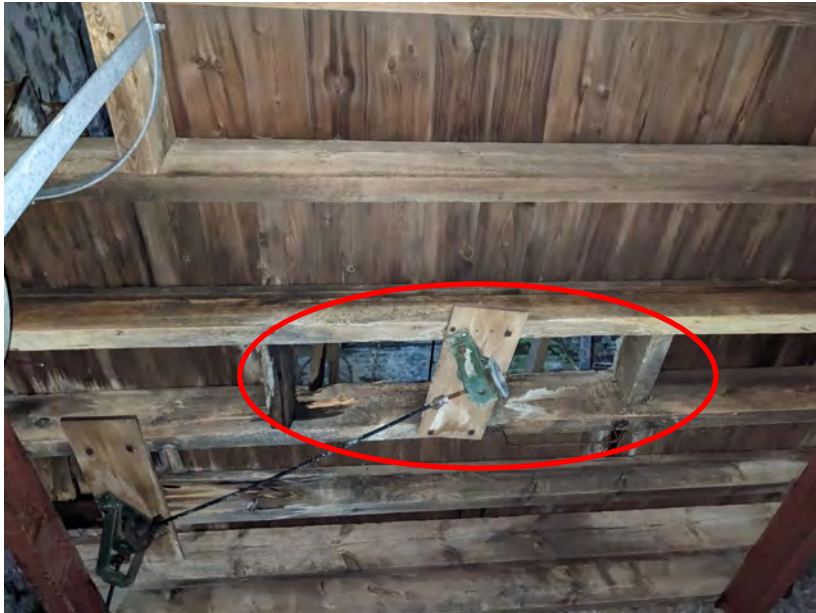
Fig 57:

3rd floor (Belfry); showing opening in 4th floor from below

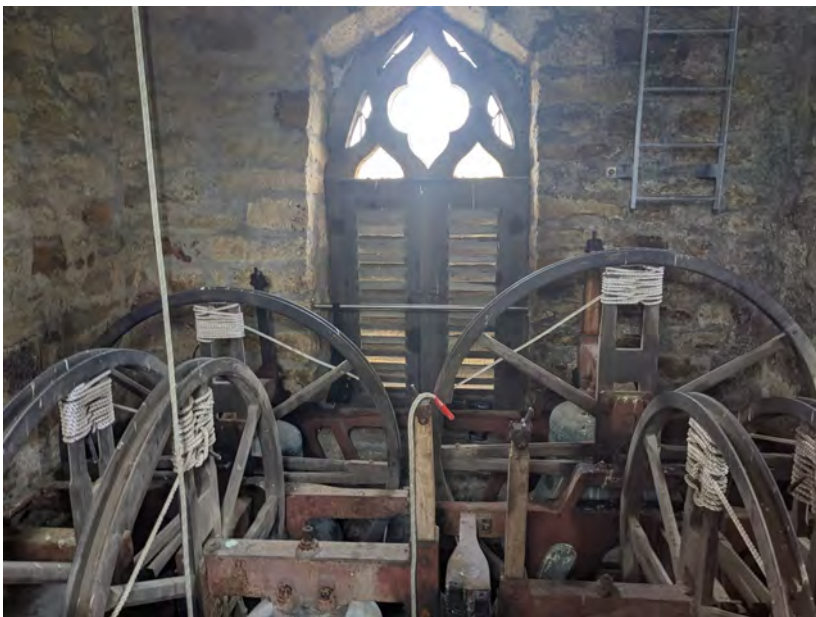
Fig 58:

3rd floor (Belfry); showing a general view of the bells and bell frame

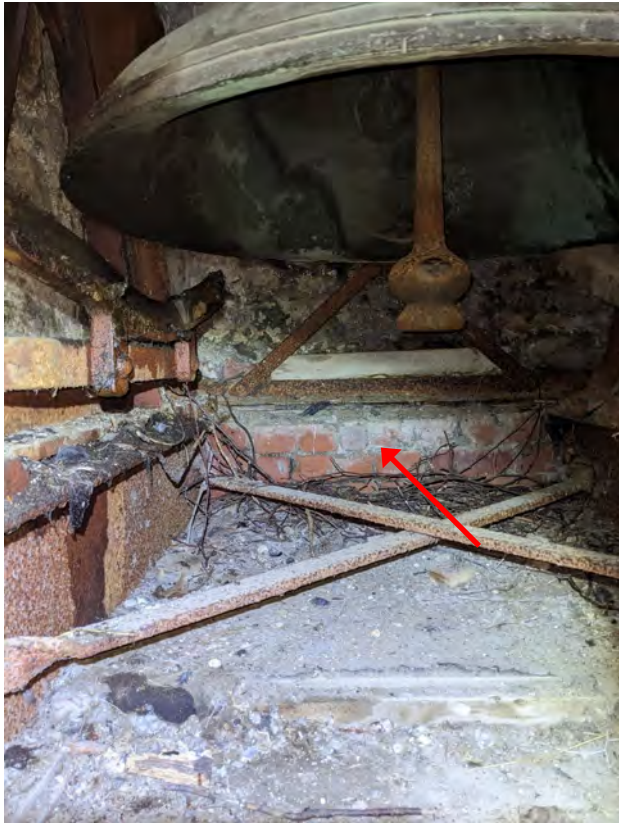
Fig 59:

3rd floor (Belfry); showing arrangement of bell frame and floor deck

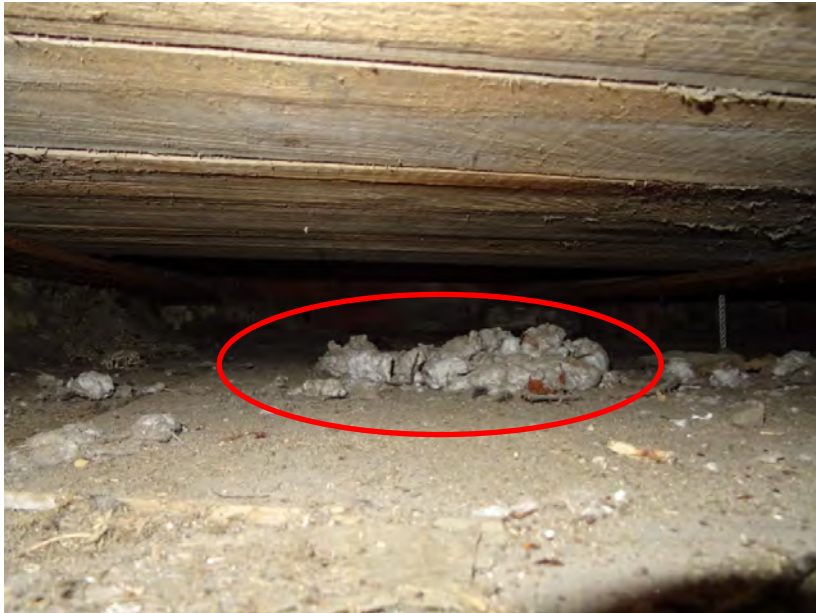
Fig 61:

3rd floor; showing the sound-dampening void between the 4th floor deck and the 3rd floor ceiling

Note: possible asbestos containing material. Inspection or disturbance of this void was not undertaken

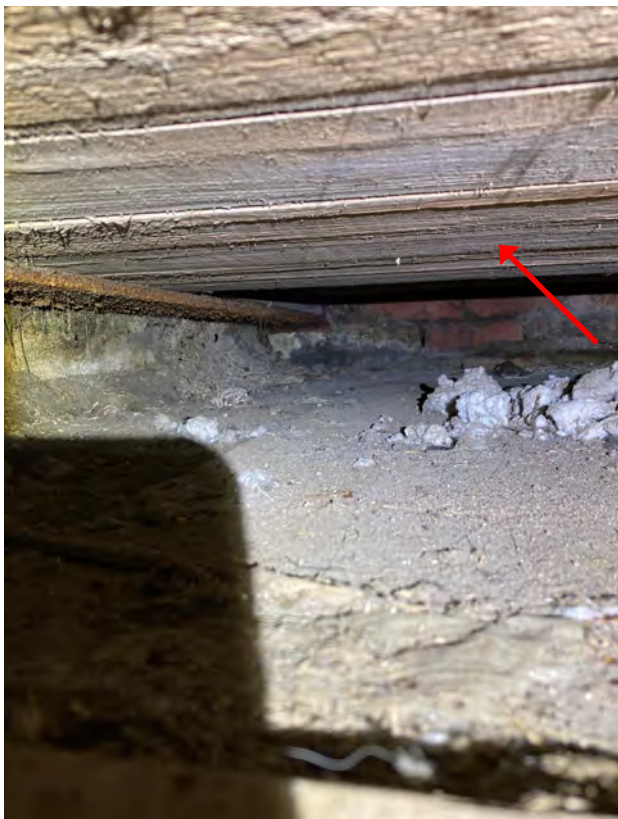
Fig 62:

3rd floor; showing the sound-dampening void between the 4th floor deck and the 3rd floor ceiling

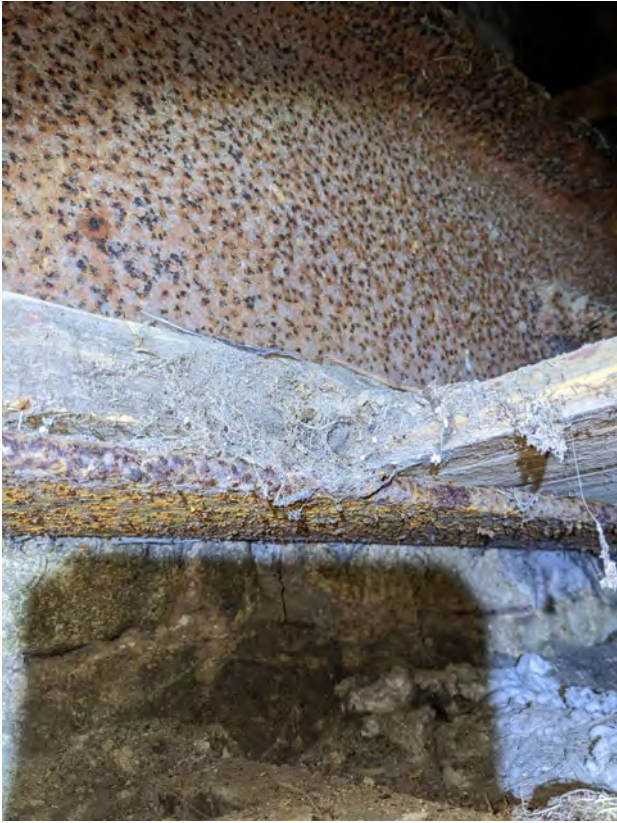
Fig 63:

3rd floor, sound-dampening void;
showing the floor deck bearing onto
the bottom flange of the steel beam

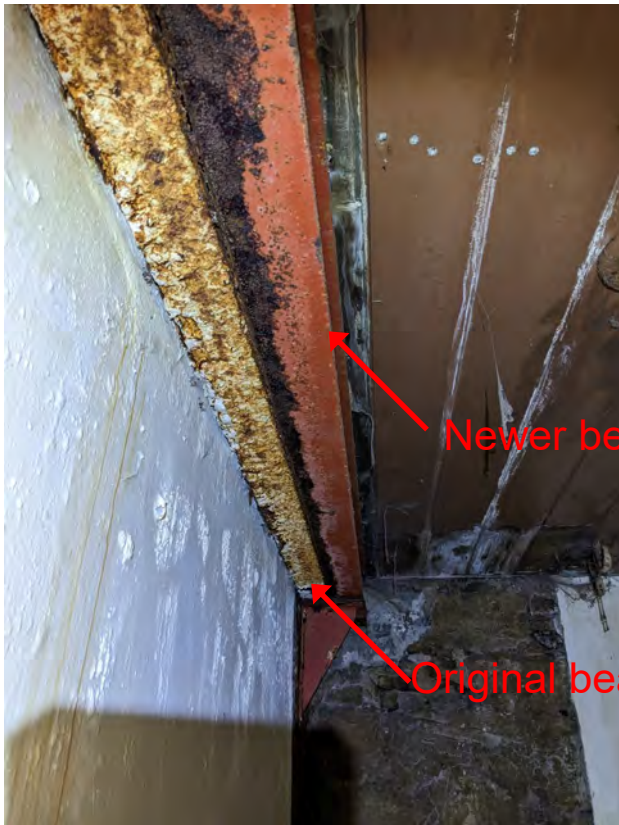
Fig 65:

2nd floor (Ringing Chamber); showing steel beams supporting structure above

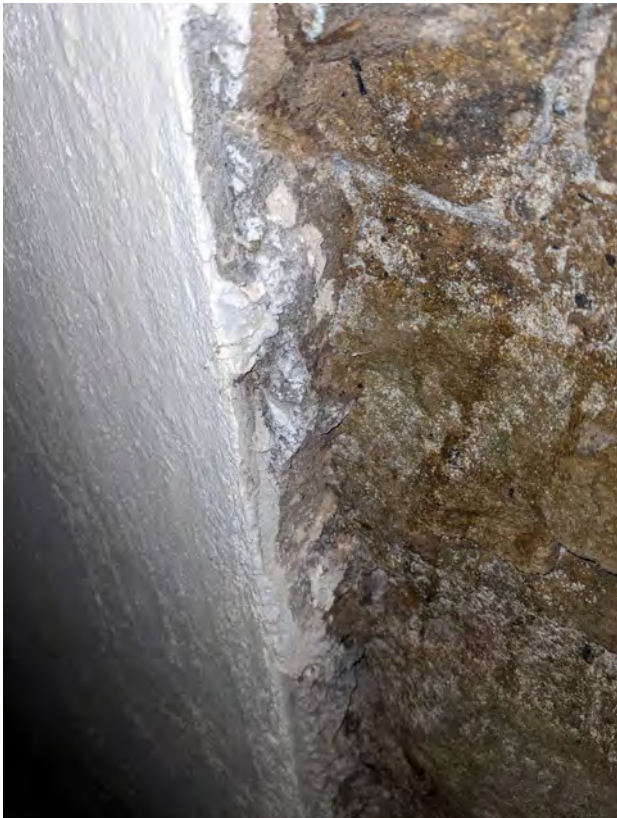
Fig 70:

2nd floor (Ringing Chamber); showing the build up of cementitious plaster

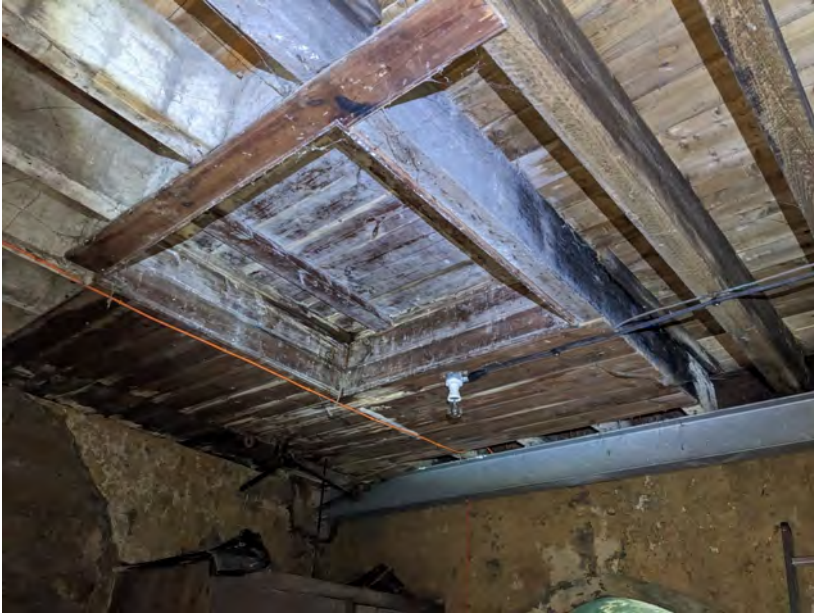
Fig 71:

1st floor (Organ Blower Room);
showing 2nd floor structure

Floor was a softwood joists and
floorboard structure retrospectively
supported on steel beams

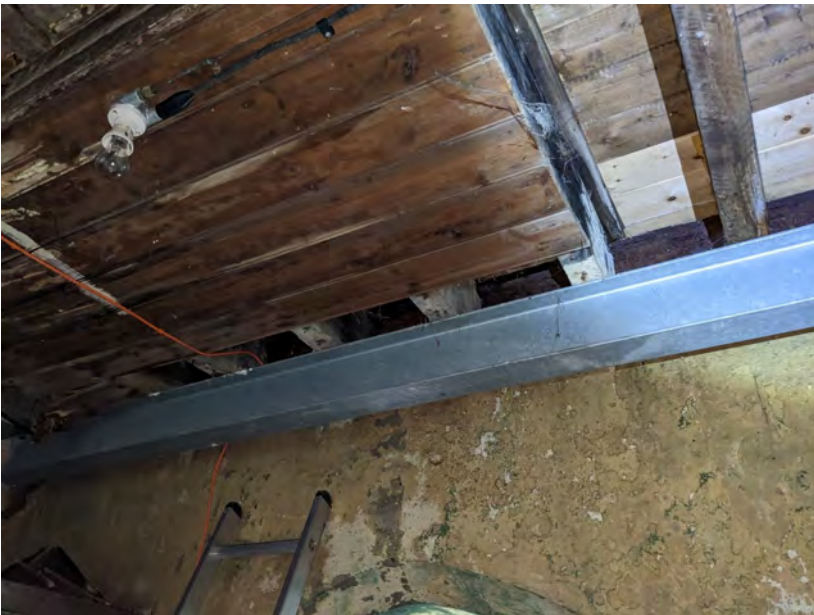
Fig 72:

1st floor (Organ Blower Room);
showing 2nd floor structure and a more
recent steel repair to the floor

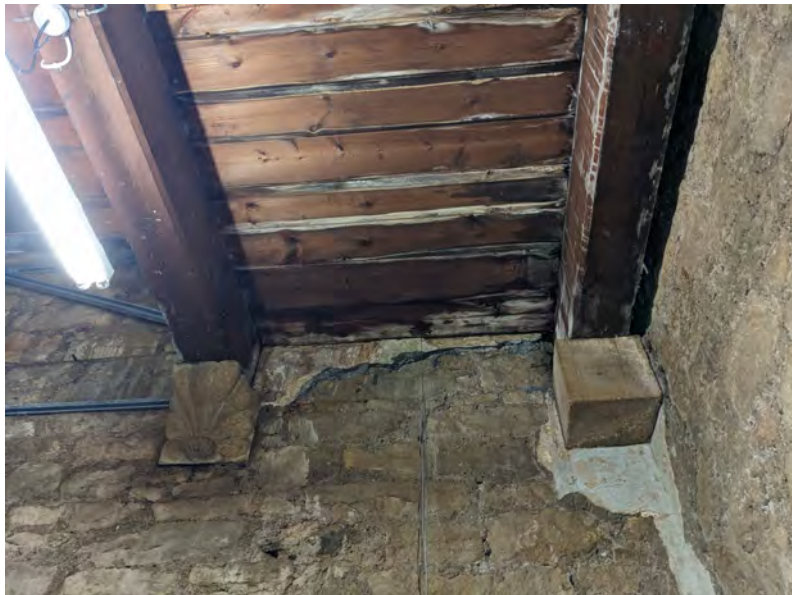
Fig 80:

Ground floor; showing 1st floor
structure

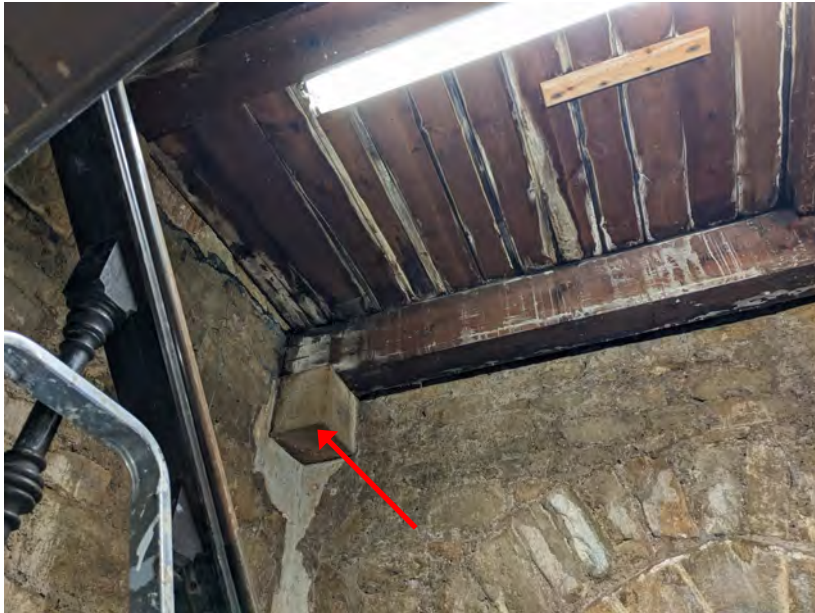
Fig 81:

Ground floor; showing 1st floor structure and an example of the masonry corbel that supported the beams

This was a repair and the beams had been trimmed and re-supported on corbel

This was most probably done in response to decay in the bearing end of the beams

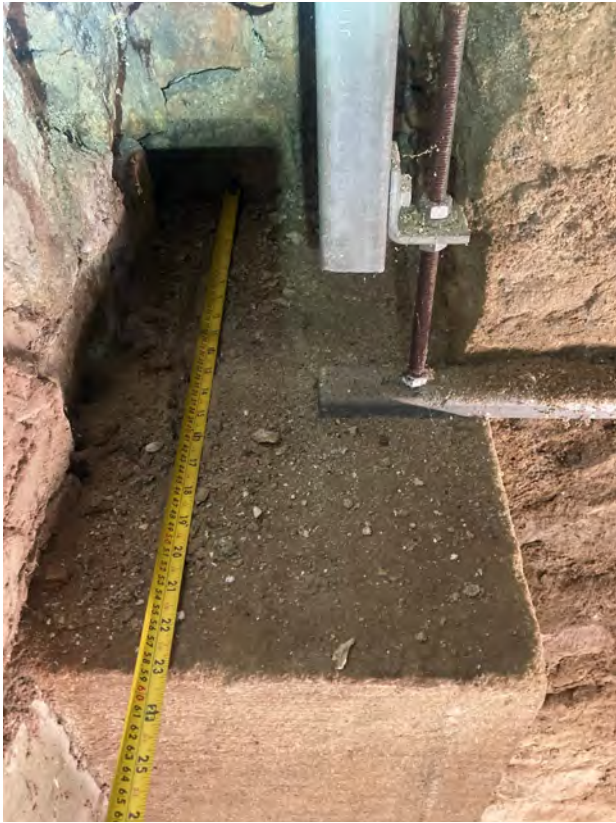
Fig 83:

Ground floor; showing stone corbel which previously supported the end of the beam which has been cut

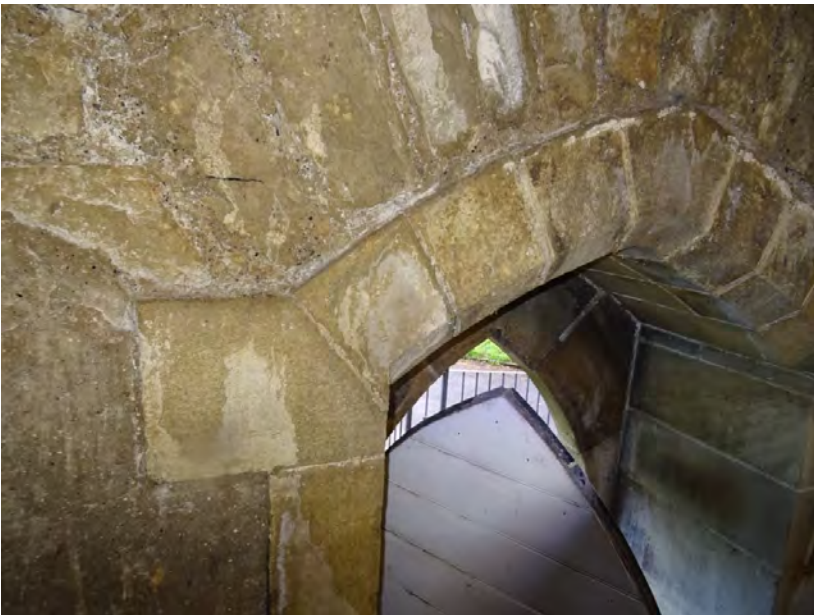
Fig 86:

Ground floor; showing lime-based mortar, plaster base coat and finishing coats bearing-up in spite of the persistent damp

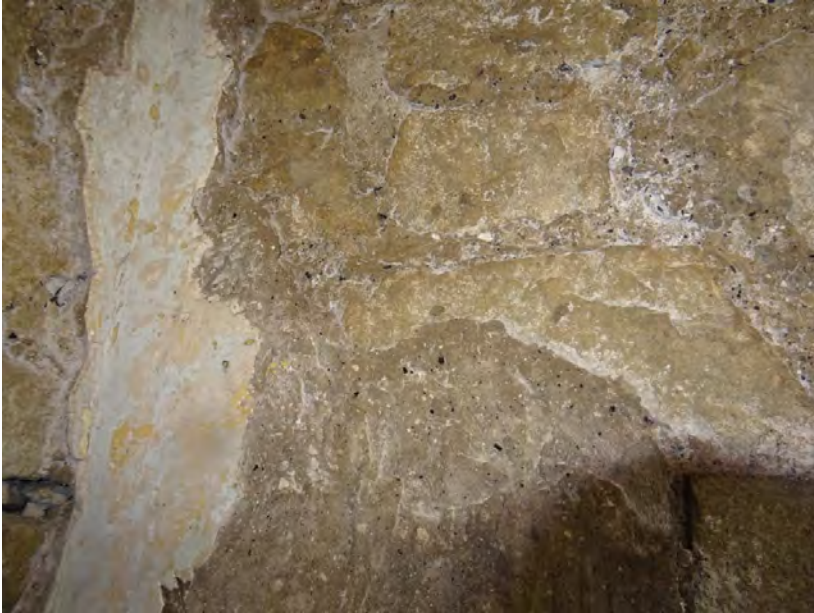
Fig 87:

Ground floor; showing lime-based mortar, plaster base coat and finishing coats

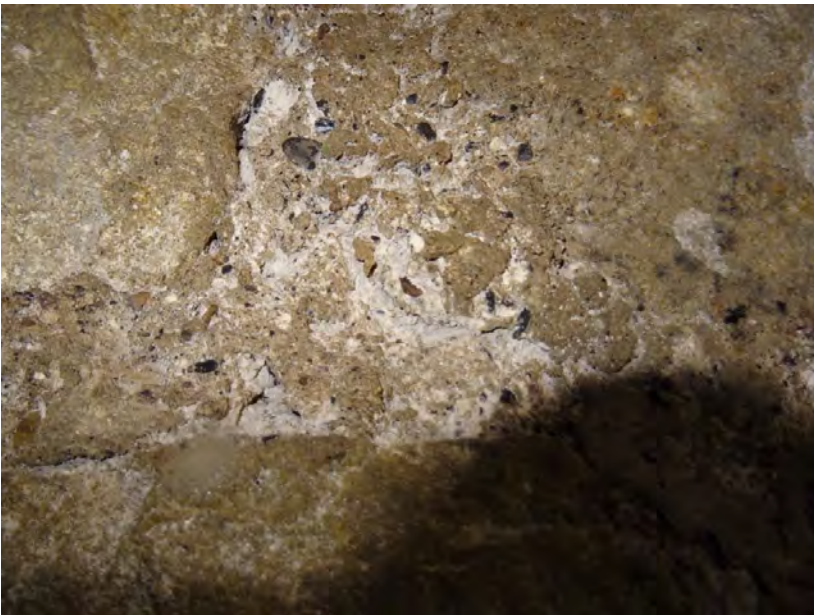
Fig 88:

Ground floor; showing lime-based plaster base coat and finishing coats

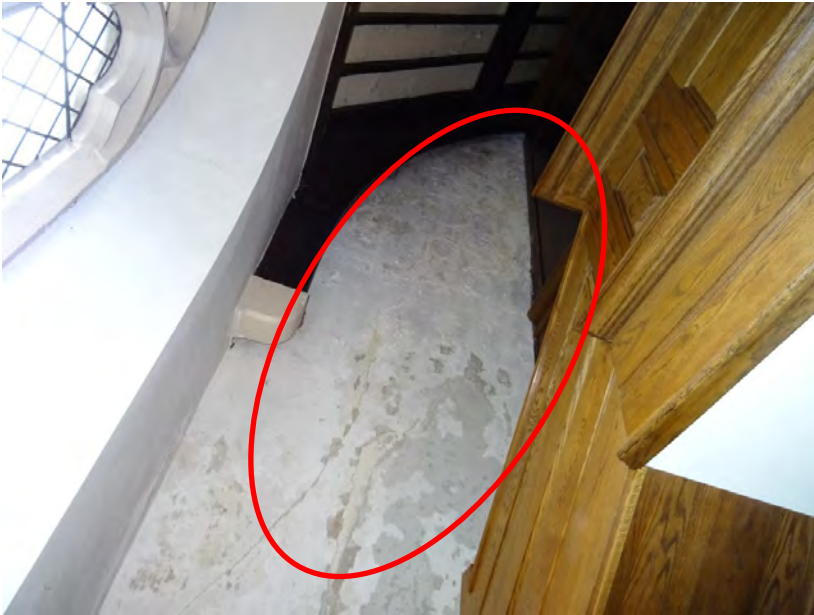
Fig 89:

Ground floor, Nave; showing the opposite side of the south-east tower wall from inside the Nave

Note; the extent of the damp-related deterioration of the finishes correlating to the south-east corner of the tower
