ST THOMAS' CHURCH TOWER, MUSBURY

INVESTIGATION OF MASONRY AND TIMBER CONDITION

JOB NO. 213-66

11-13 APRIL 2023

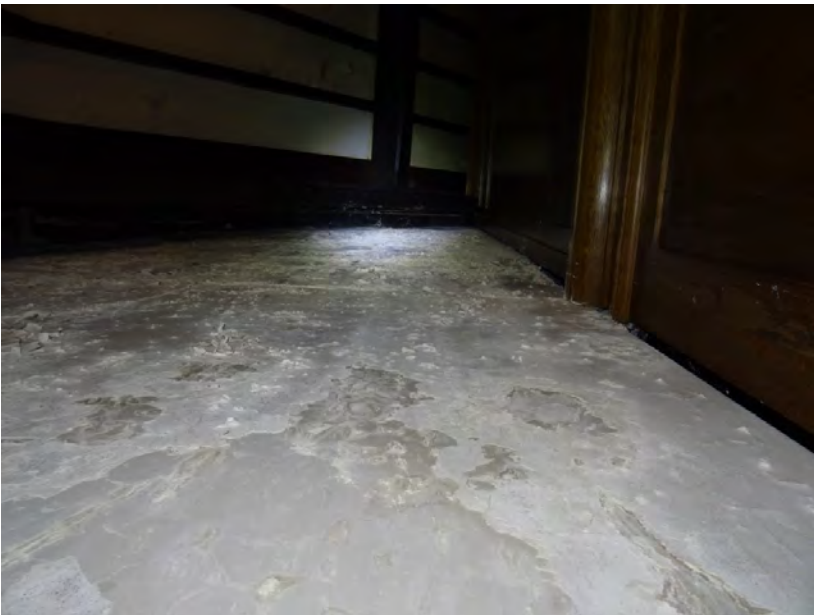
Fig 90:

Ground floor, Nave; showing the opposite side of the south-east tower wall from inside the main body of the church

Note; the extent of the damp-related deterioration of the finishes

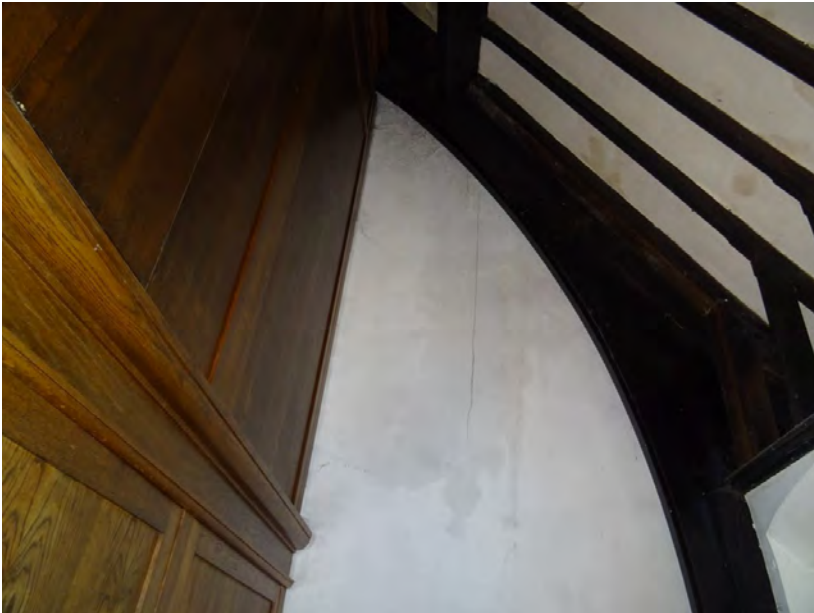
Fig 91:

Ground floor, Nave; showing opposite side of the north-east tower wall from inside the main body of the church

Note; the lesser extent of damp-related deterioration of the finishes

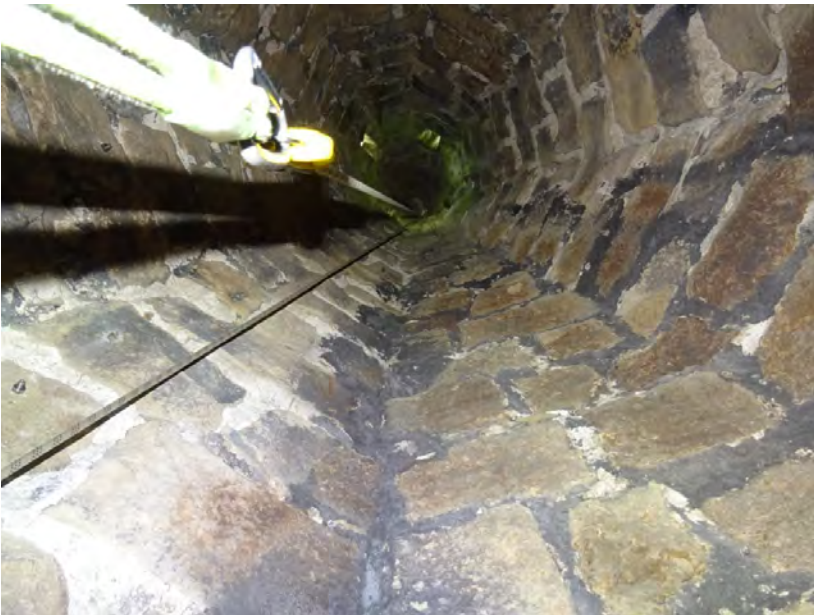
Fig 92:

Interior of the spire during roped access survey

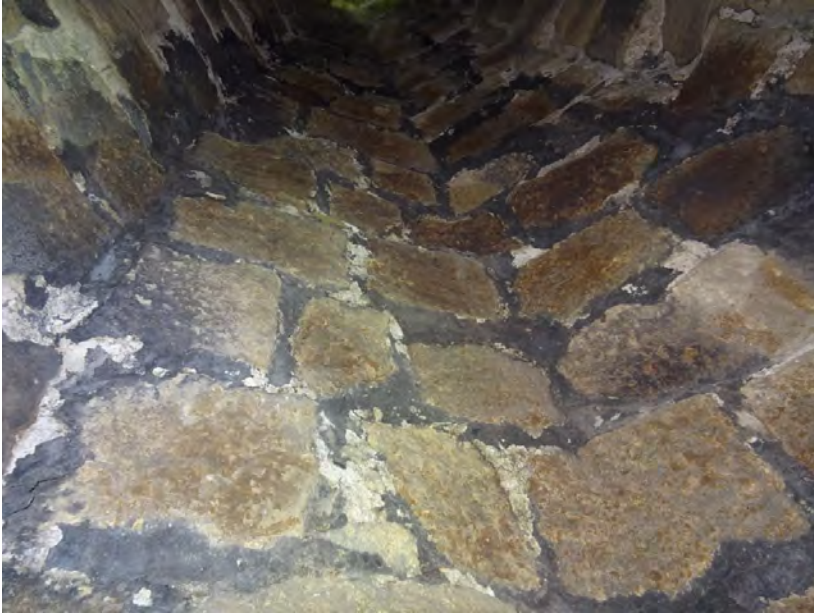
Fig 93:

Interior of the upper spire accessed by roped techniques

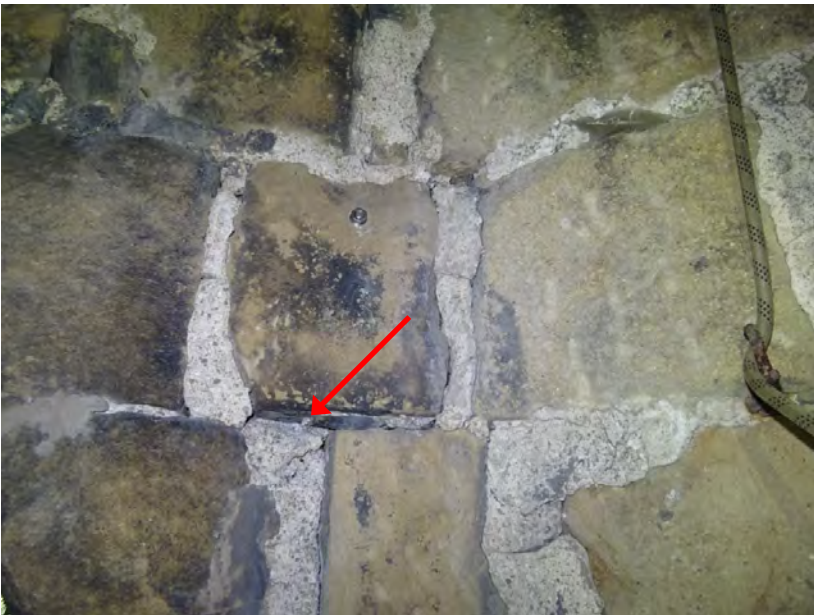
Fig 94:

Interior of the spire in the upper third of its height

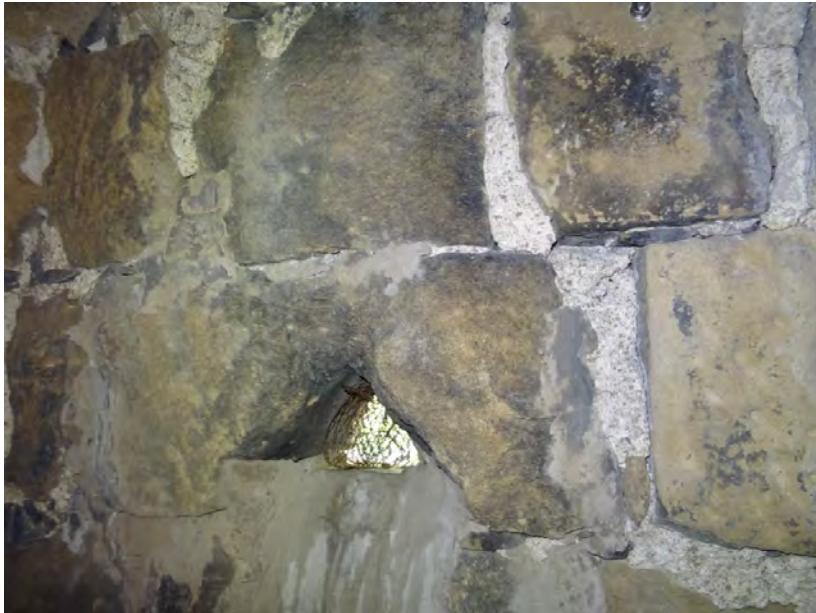
Fig 95:

Interior of the spire

One of the uppermost window openings

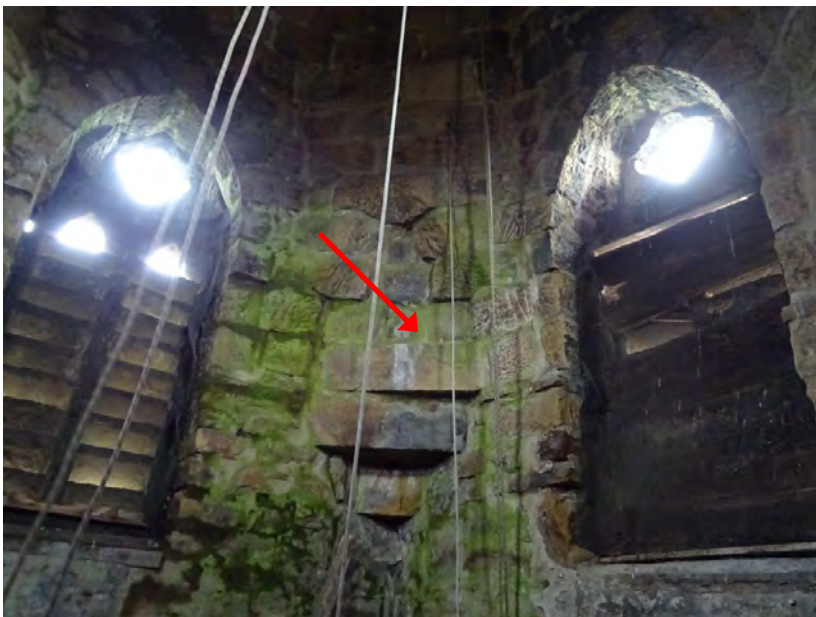
Fig 96:

Spire interior

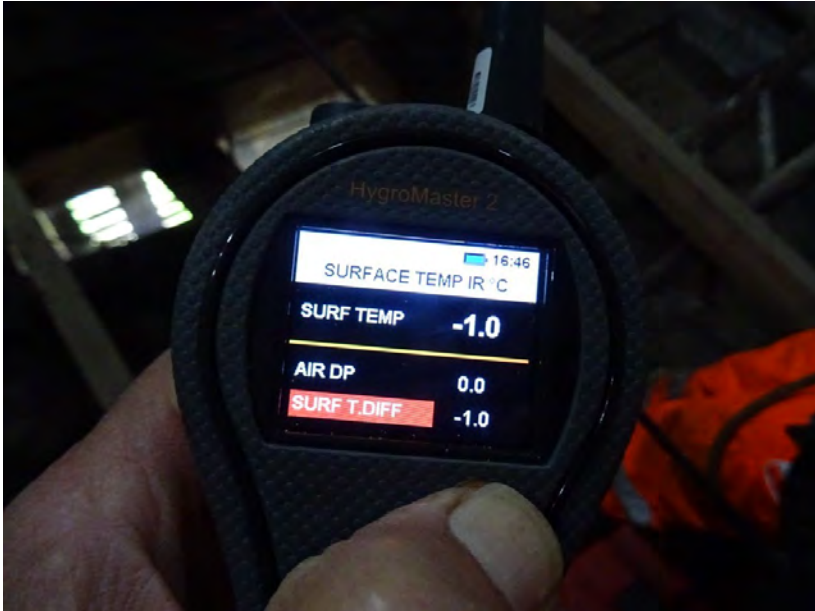
Fig 97:

Spire interior

Surface temperature measurement at the location shown in Fig 96 above

Condensation was occurring at the time

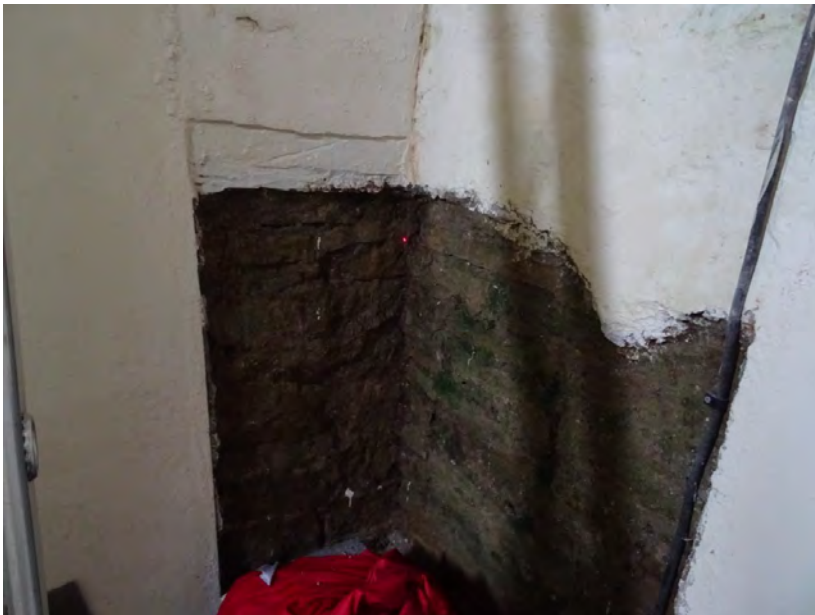
Fig 98:

Ringling chamber

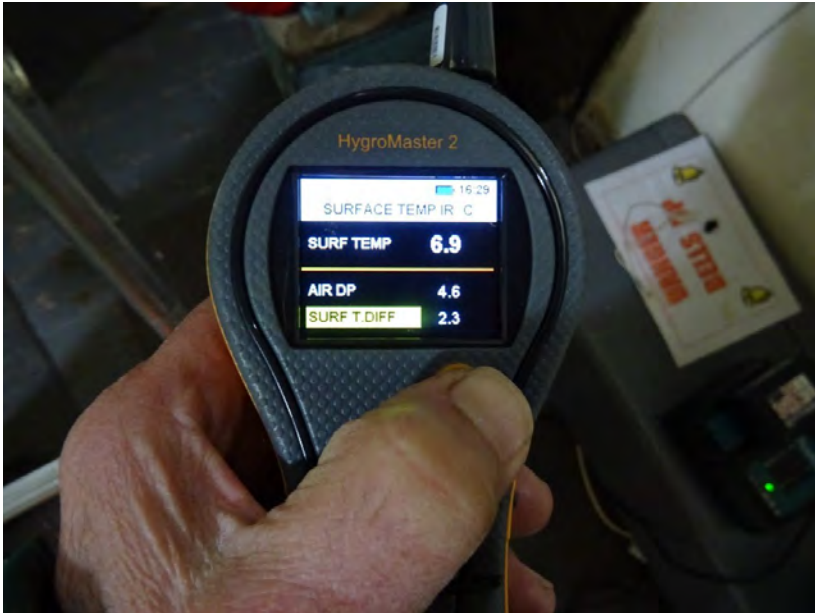
Fig 99:

Ringling chamber

Condensation was not occurring at the time but the potential for condensation was high because at mid-day there was less than 3°C separation between surface temperatures and dew point

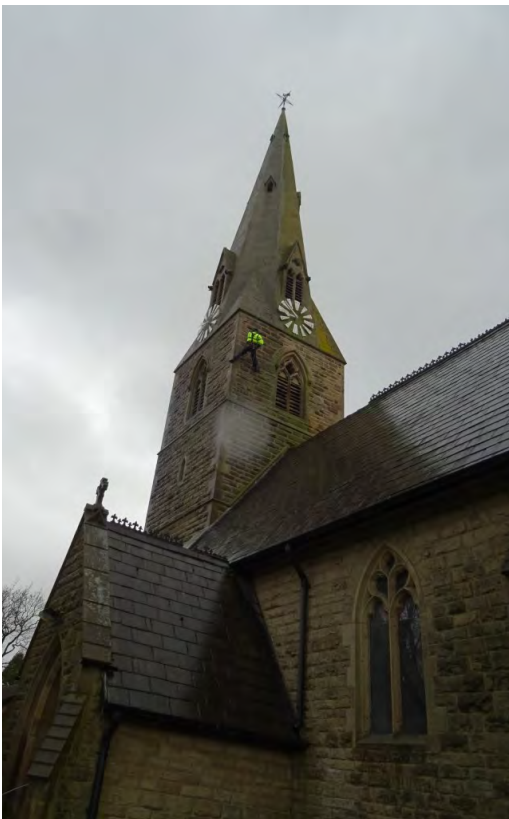
Fig 100:

Roped access being used to closely examine and test masonry joints

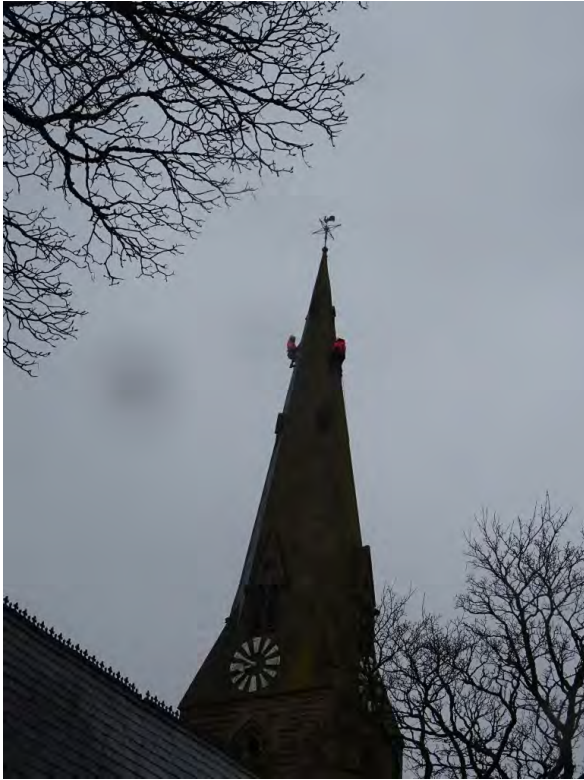
Fig 101:

The highest point surveyed by tactile examination

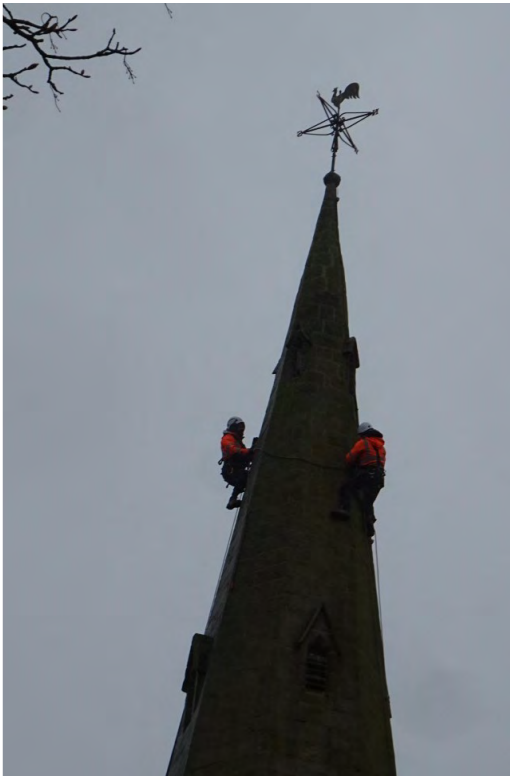
Fig 102:

The highest point surveyed by tactile examination
